West Liberty University

2019 CAMPUS MASTER PLAN
& RECOMMENDATIONS

WEST LIBERTY, WEST VIRGINIA

imi MILLS
GROUP

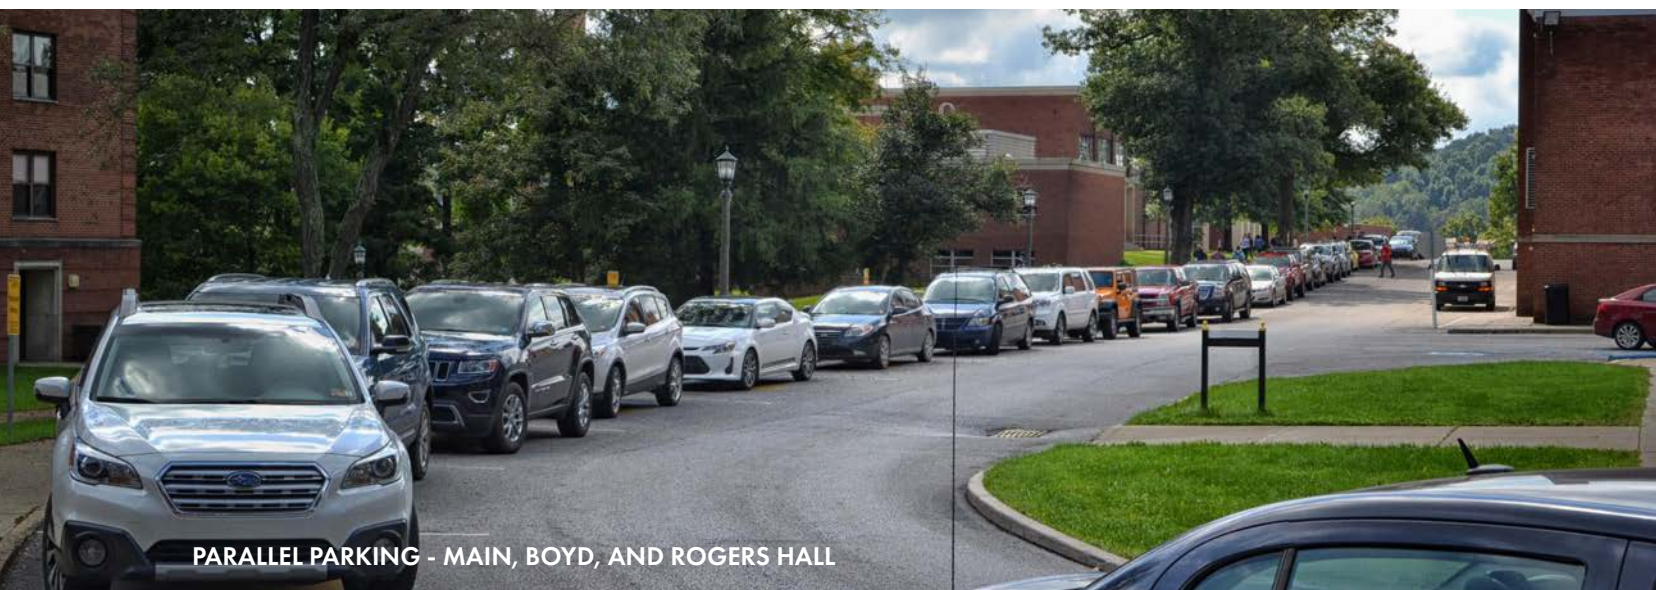
PARALLEL PARKING - MAIN, BOYD, AND ROGERS HALL

The majority of parking areas on campus exist around the outer edges of the site along one and two-way roads. The parking lots that immediately hug the Quad and South Drive are shown to be of the highest priority and vehicular traffic seems to focus on finding spots here. These parking spots (as seen below) also happen to be largely curbside in nature.

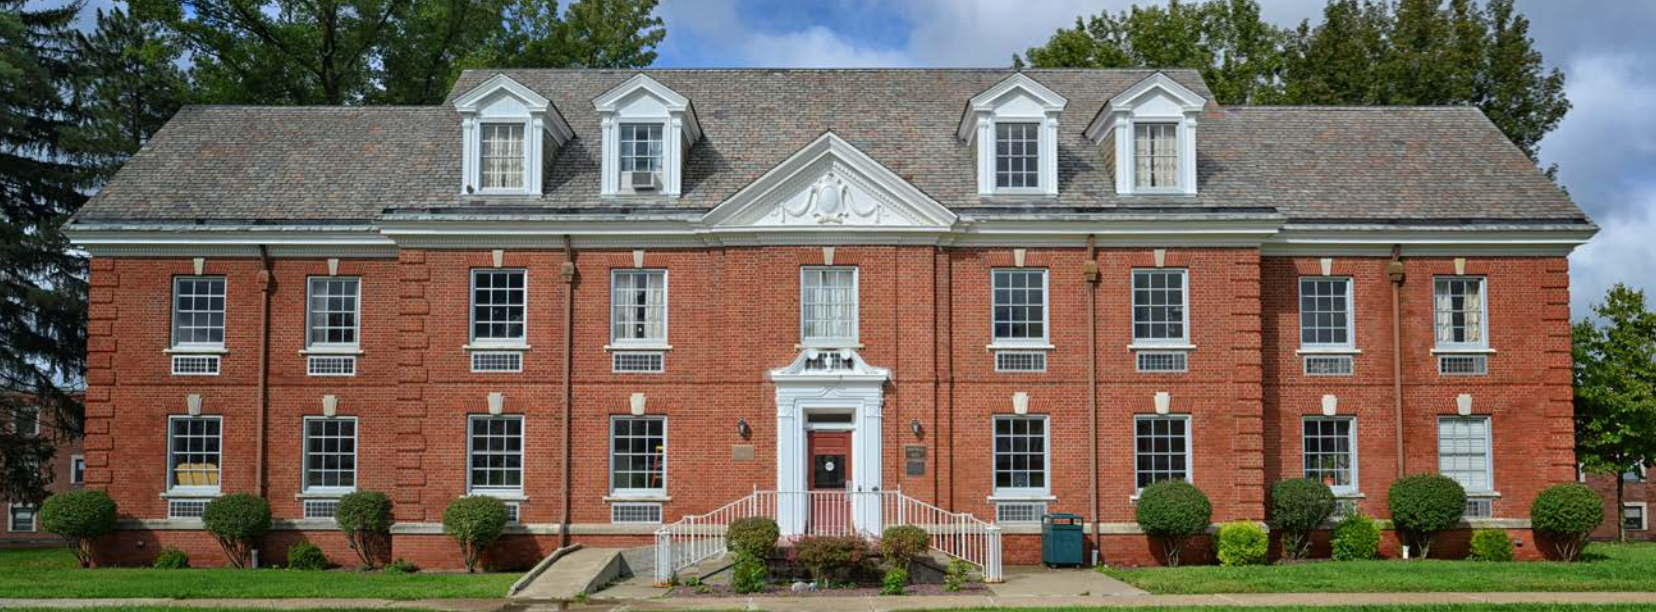
REVIEW & RECOMMENDATIONS

In 2017 WLU performed a building assessment report of all properties on or off campus used by the University. The report identifies the building area, the year it was constructed, the type of construction including building systems, and a conditions matrix. This information was then analyzed to create a list of necessary improvements to select properties along with cost estimating.

- 1. It is noted that the 2017 cost estimate will be subject to a 4% per year increase due to cost of living. This will yield an 8.16% cost increase if the project occurs in 2019. The same 4% increase needs to be considered if projects are extended to later years.***

- 2. Projects that have been funded since 2017 are identified and noted to be removed from the cost estimate.***
- 3. Properties that were costed in 2017 that need additional work have been noted and the costs adjusted accordingly. This has been highlighted in red in the appendix.***

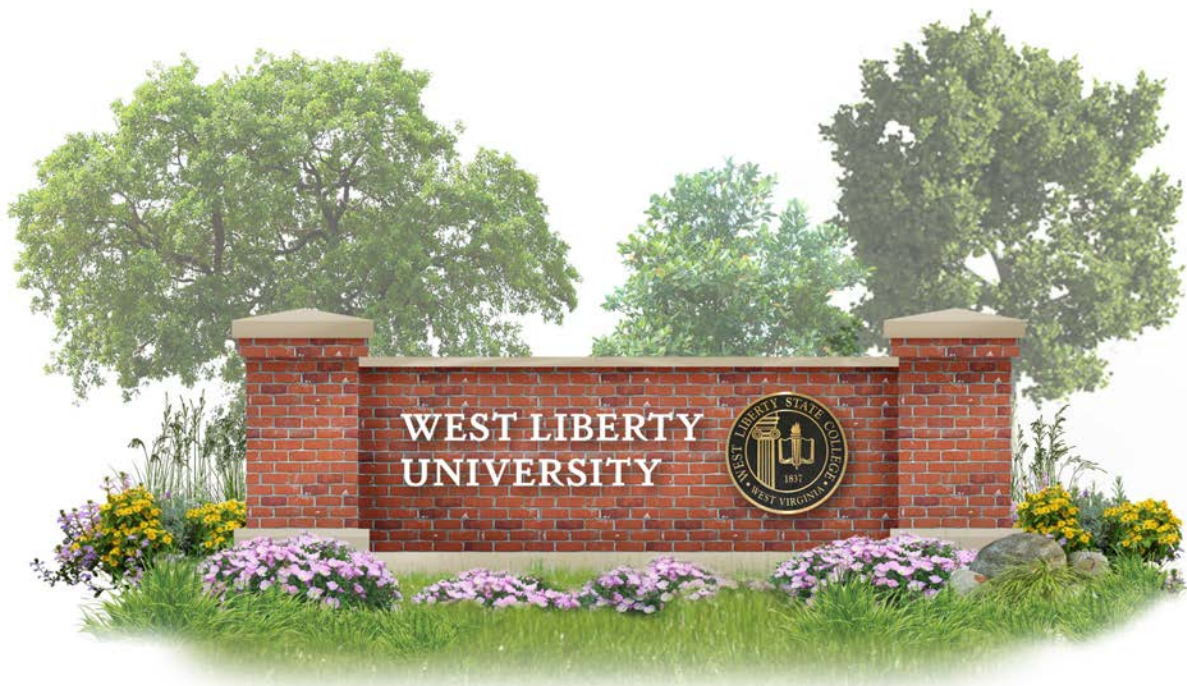
PROPOSED MONUMENT STYLE SIGNAGE

The letters and graphics should have a high contrast value against the brick (at least 70%), a prominent seal, columnar end pieces, and attractive landscape flanking the signage. These elements will help ensure that the gateway signage monuments are highly readable and aesthetically appropriate.

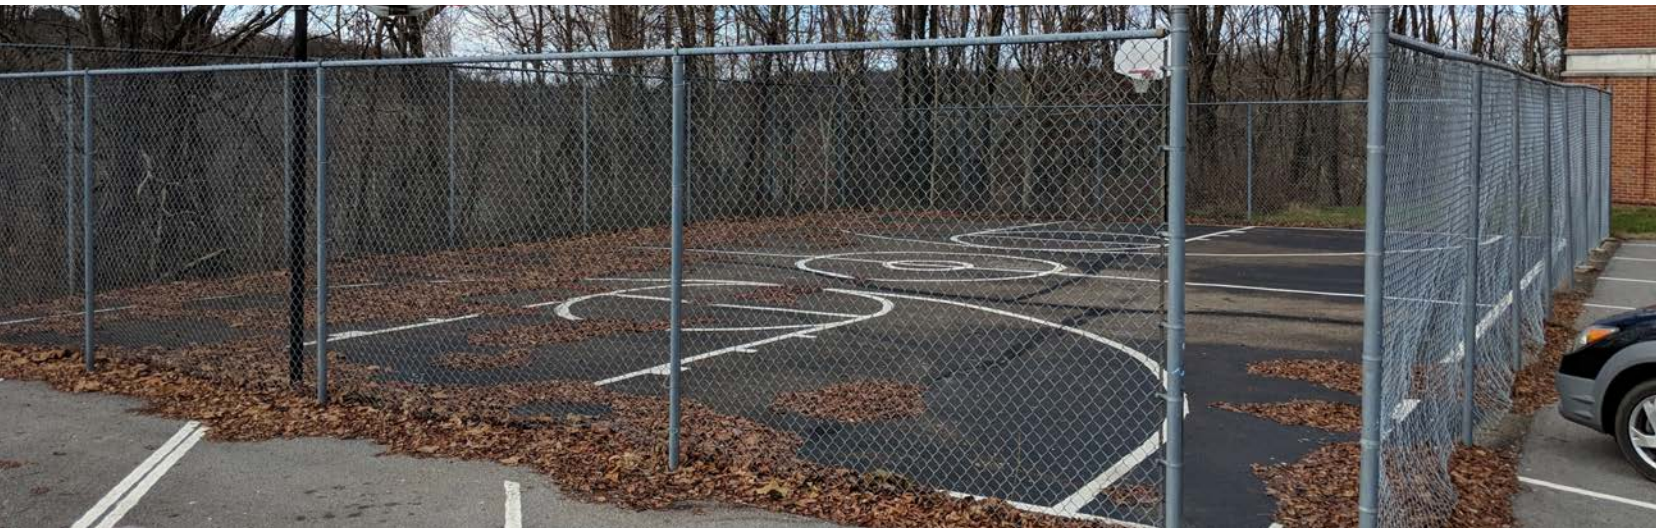
1. BETA HALL BASKETBALL COURT

The only basketball court on campus is located near the southwestern corner behind Beta Hall. Due to its distance from the core of campus and without any immediate access to restrooms or other amenities, the court is highly underutilized and hard to reach.

1. RELOCATION OF COURT AND/OR ADDITIONAL COURTS NEAR CURRENT TENNIS AREA (SEE SECTION 10)
2. CREATING BUFFER SPACE BETWEEN COURTS AND VEHICULAR PARKING - LANDSCAPE ELEMENTS/GRASS
3. SEATING AREAS
4. IMPROVED LIGHTING

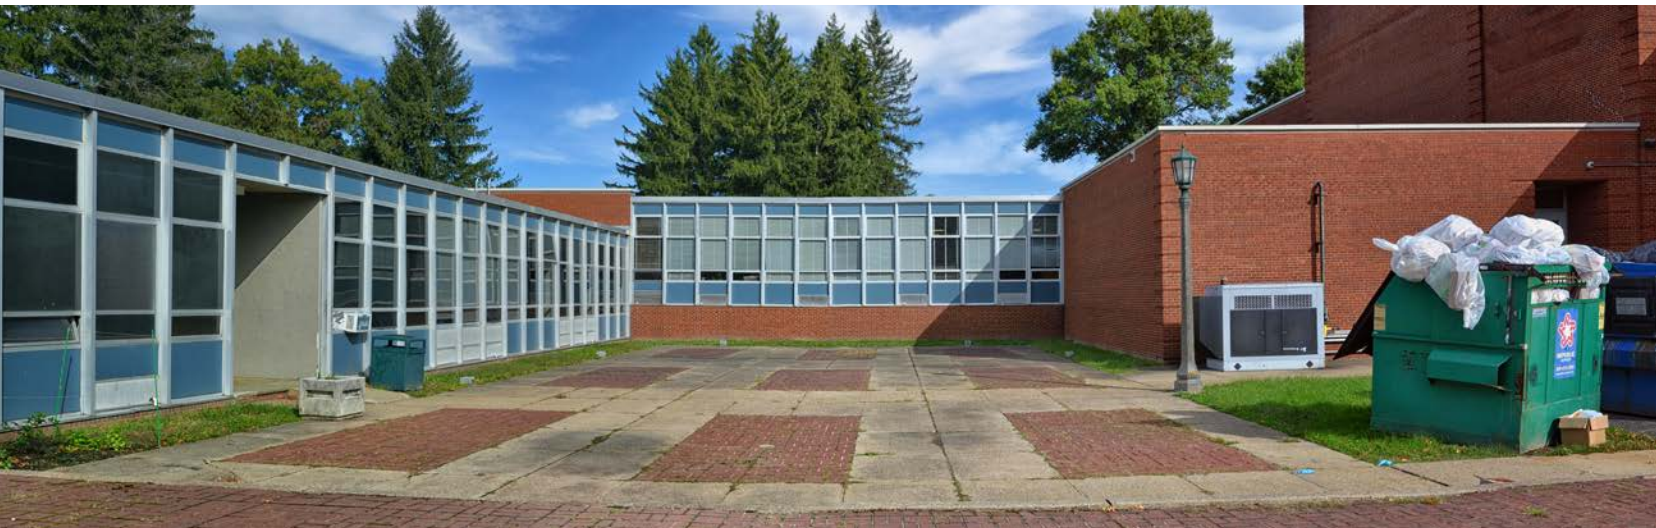
2. HALL OF FINE ARTS COURTYARD

Embedded in the heart of the Hall of Fine Arts and Media Arts Center buildings is a highly underutilized open air courtyard. Walled off on three of four sides and completely covered in hardscape, the space doesn't offer any aesthetic views or landscape features but does provide a sense of solitude.

1. TRASH RELOCATION/SCREENING - ODOR MITIGATION
2. SHADE PROVISIONS & LANDSCAPE PLANTINGS TO SOFTEN THE AESTHETIC AGAINST THE BUILDINGS
3. SEATING OPTIONS
4. POSSIBLE ARTSCAPE INSTALLATION LOCATION (SEE SECTION 09)

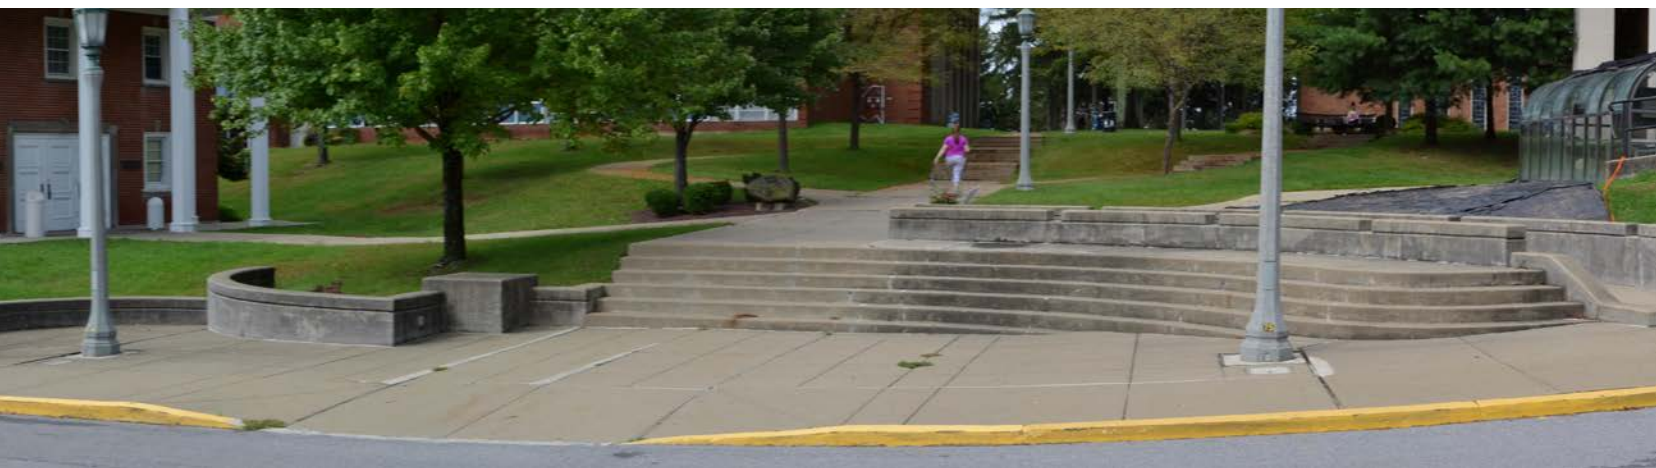
3. SOUTH DRIVE SPACE

Just off the southeastern corner of the main quad is a small space that serves to link several buildings together. It includes a handicapped accessible ramp, stairs, and a few seating spaces. The area feels as if it lacks identity or magnetism and could use added features to increase appeal and usage.

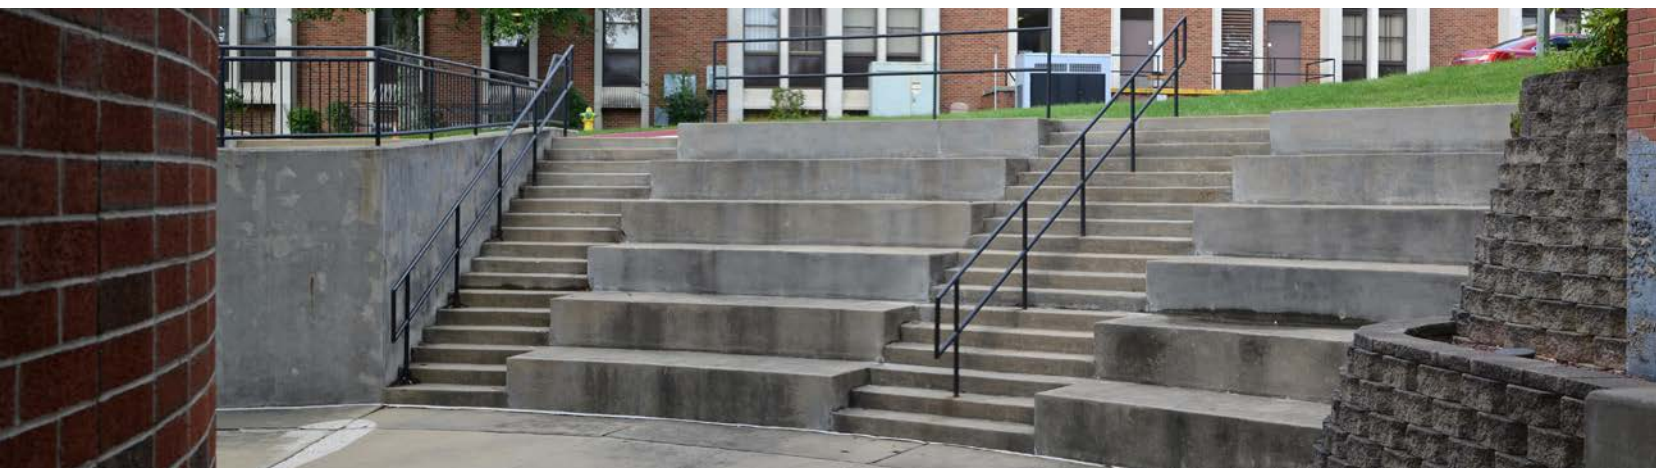
4. OUTDOOR SEATING

Adjacent to the main entry into the ASRC Building is a very small pocket space with stadium seating that was originally planned to host small classes and events. Currently the space feels vacant, exposed, and the hardscape is in need of repair in several areas.

1. HARDSCAPE REPAIR FOR SAFETY AND AESTHETIC VALUE
2. IMPROVEMENTS TO SEATING (SEAT CAPS, BACKING, AESTHETIC UPGRADES)
3. SHADE PROVISION (ARCHITECTURAL SHADE STRUCTURE OR LANDSCAPE TREES)
4. LANDSCAPE BUFFERING AT TOP OF SEATING TO SCREEN FOR PRIVACY & NOISE FROM SOUTH DRIVE
5. IMPROVED LIGHTING
6. ATTENTION TO PROGRAMMING

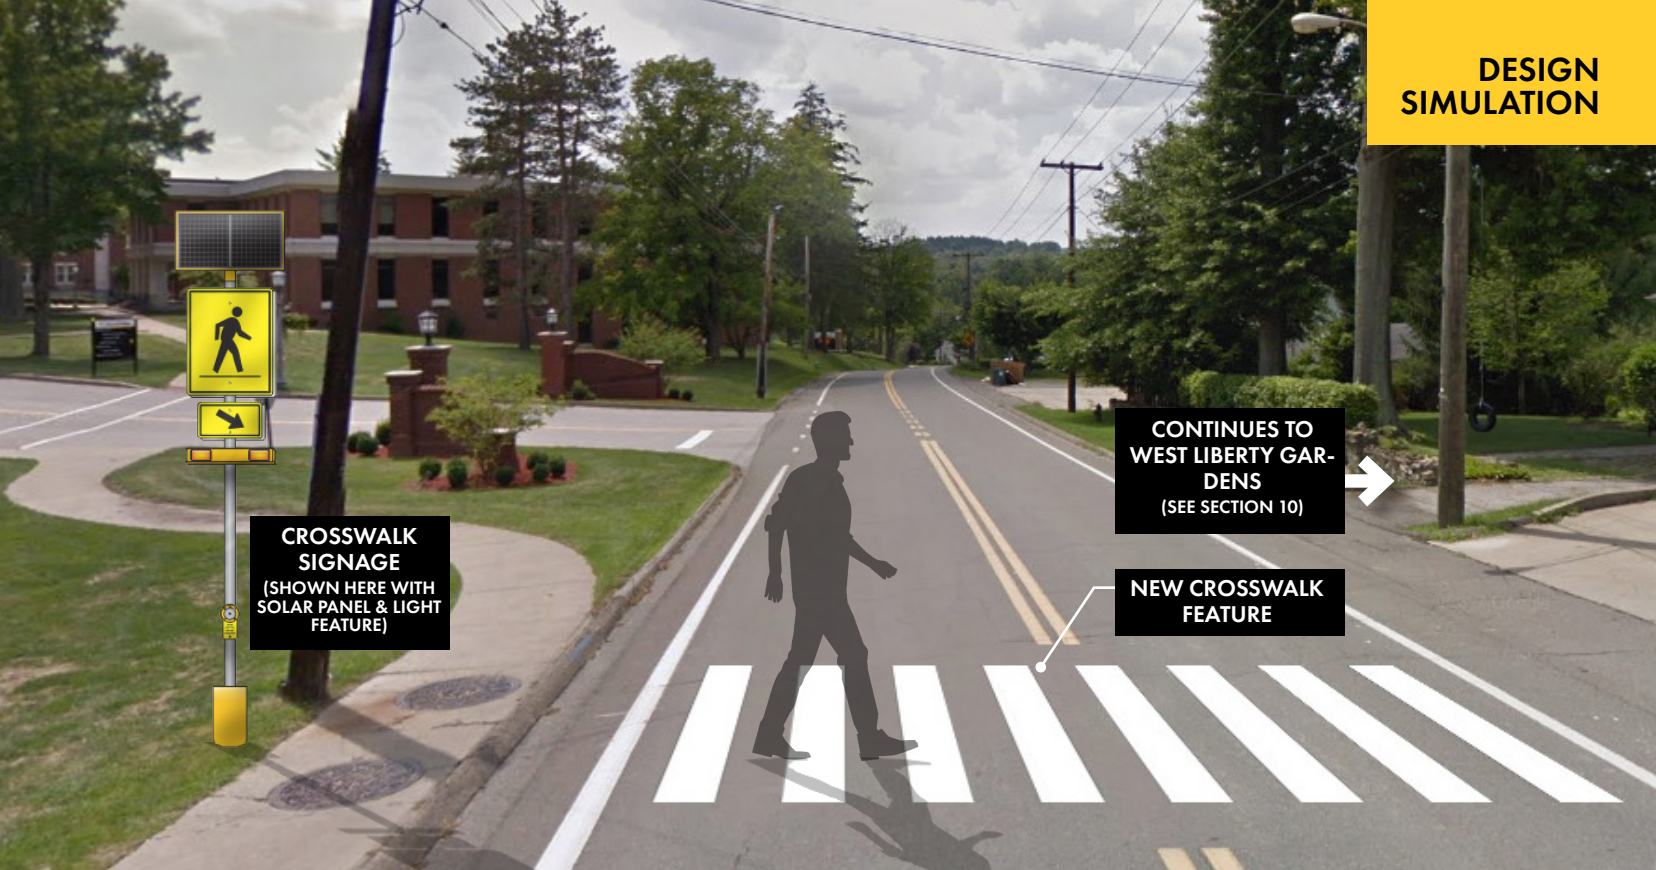
VAN METER WAY CROSSING

Currently there are no demarcated crosswalks for pedestrians to safely cross Van Meter Way. With the college’s plans to adjoin the main campus to a future development area called West Liberty Gardens near the main entrance (see Section 10), a safe and highly visible crosswalk design should be considered here.

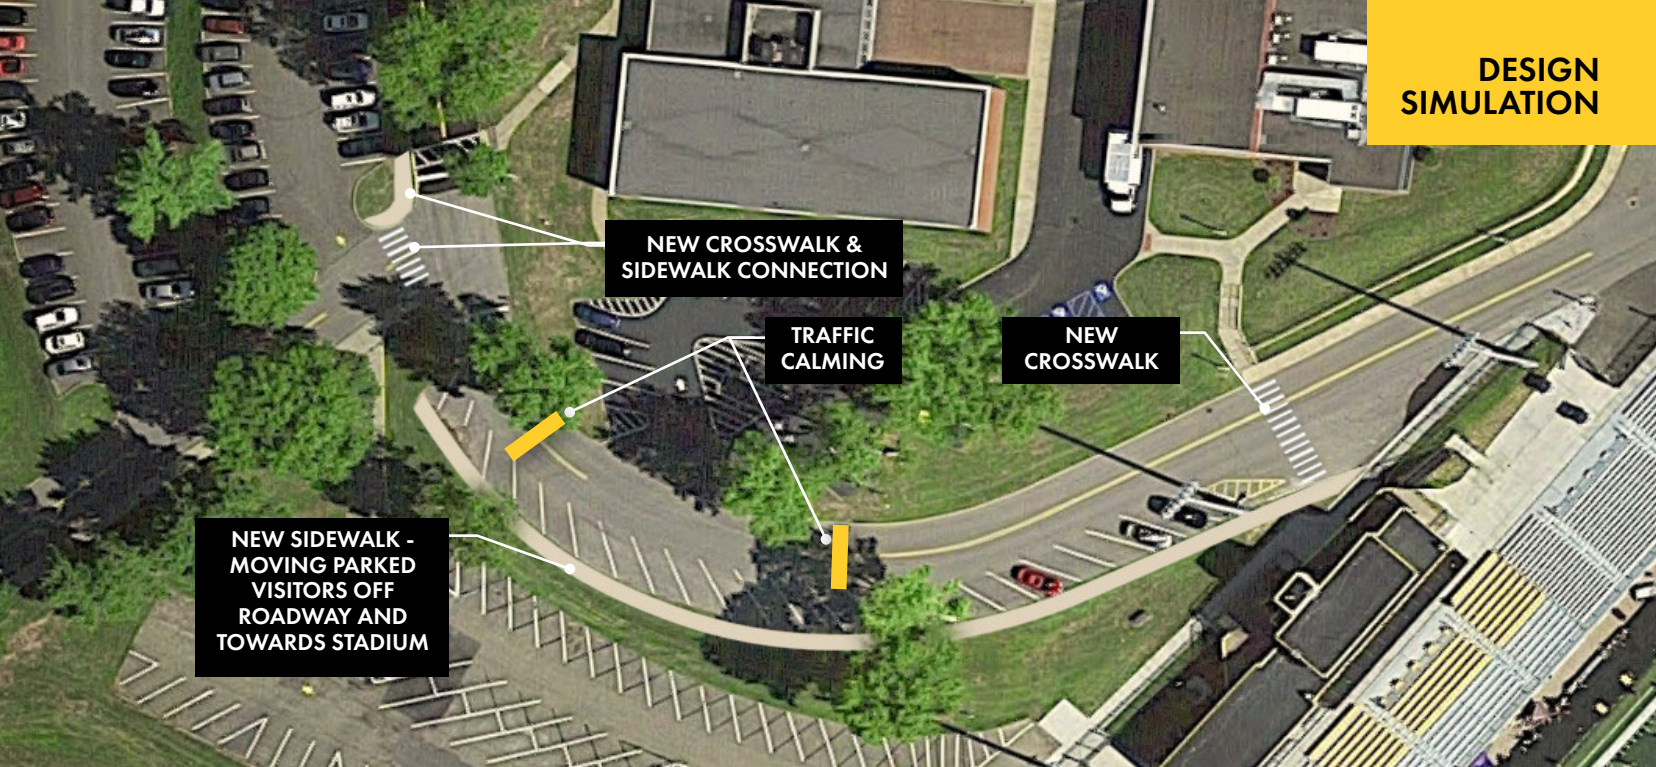
BETA DRIVE INTERSECTION

The intersection of Beta Drive and South Drive is an area of concern in that it creates a complex series of vehicular traffic patterns and parking adjacencies that all come together in a small space. The addition of the curved section of South Drive that trails behind the Hall of Fine Arts towards the parking at the football stadium adds another challenging element of visibility and traffic safety. Because of the orientation of the spaces here, most vehicular approaches with the intent to park come from a counter-clockwise flow along South Drive as they enter forward-facing into the spaces. This forces the departing vehicles to back out into traffic that may have difficulties seeing them due to the turn or other parked vehicles. In addition to the parking, there are areas of sidewalk that terminate into lawn and crosswalk sections that could be recreated to help aide a smoother flow of traffic.

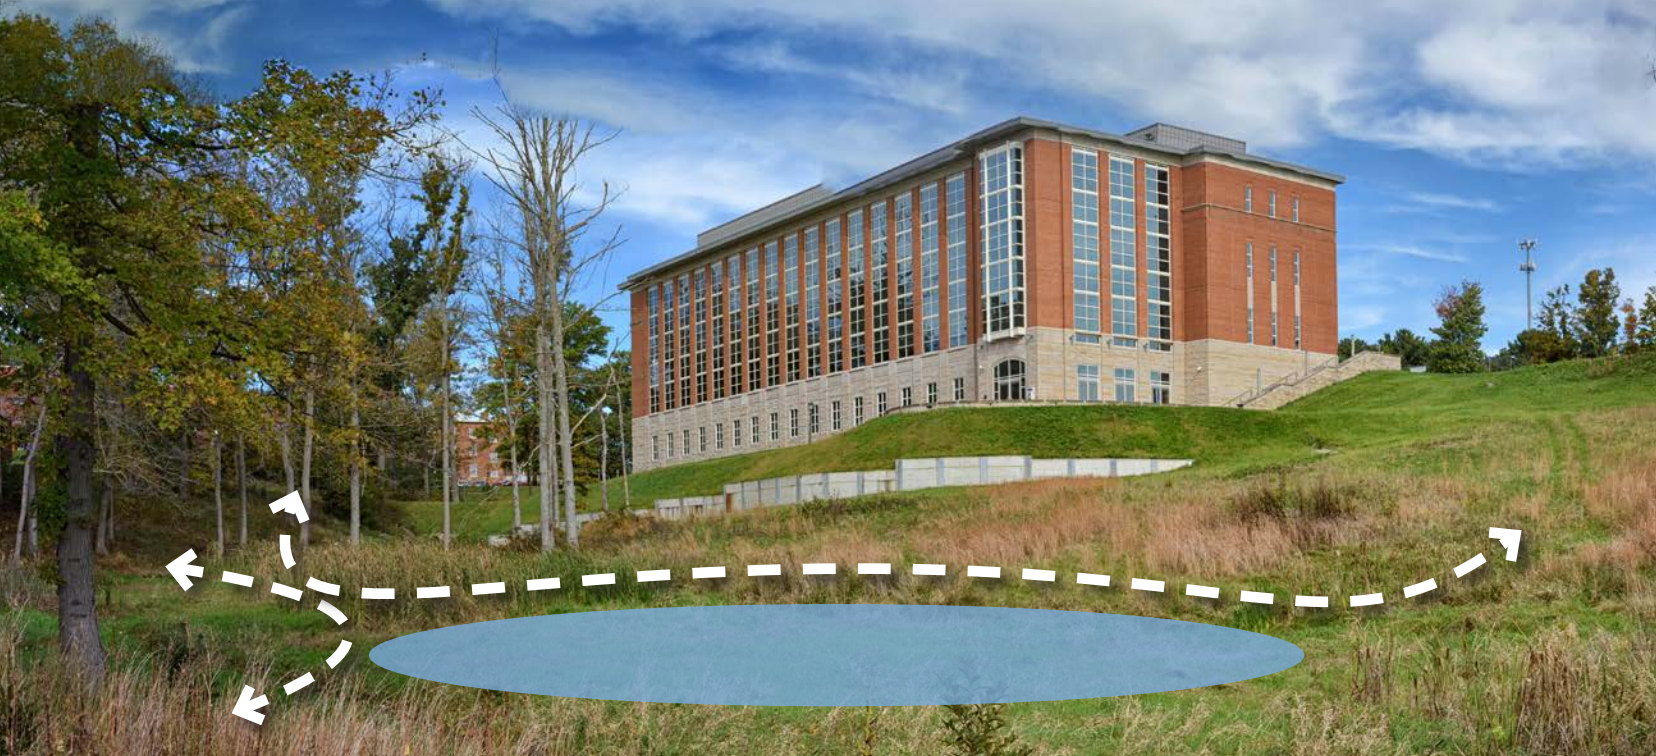
CAMPBELL HALL AREA

The forested area and grass-covered hillside just south of Campbell Hall remains one of the last truly naturalized areas on campus. Because of the topography and its bowled shape, it forms a natural basin for water capture and runoff as well as forming a habitat for smaller animals, insects, and birds. While the area near the top of the hillside along Faculty Drive may be considered for future development (Section 10), the forested section and base of this area should be maintained and protected to ensure existing natural systems aren't negatively impacted. The adjacency of parking and Lakeview Drive's vehicular traffic should also be considered when adjustments are made as water runoff and visual screening can be modified and/or enhanced (Section 05).

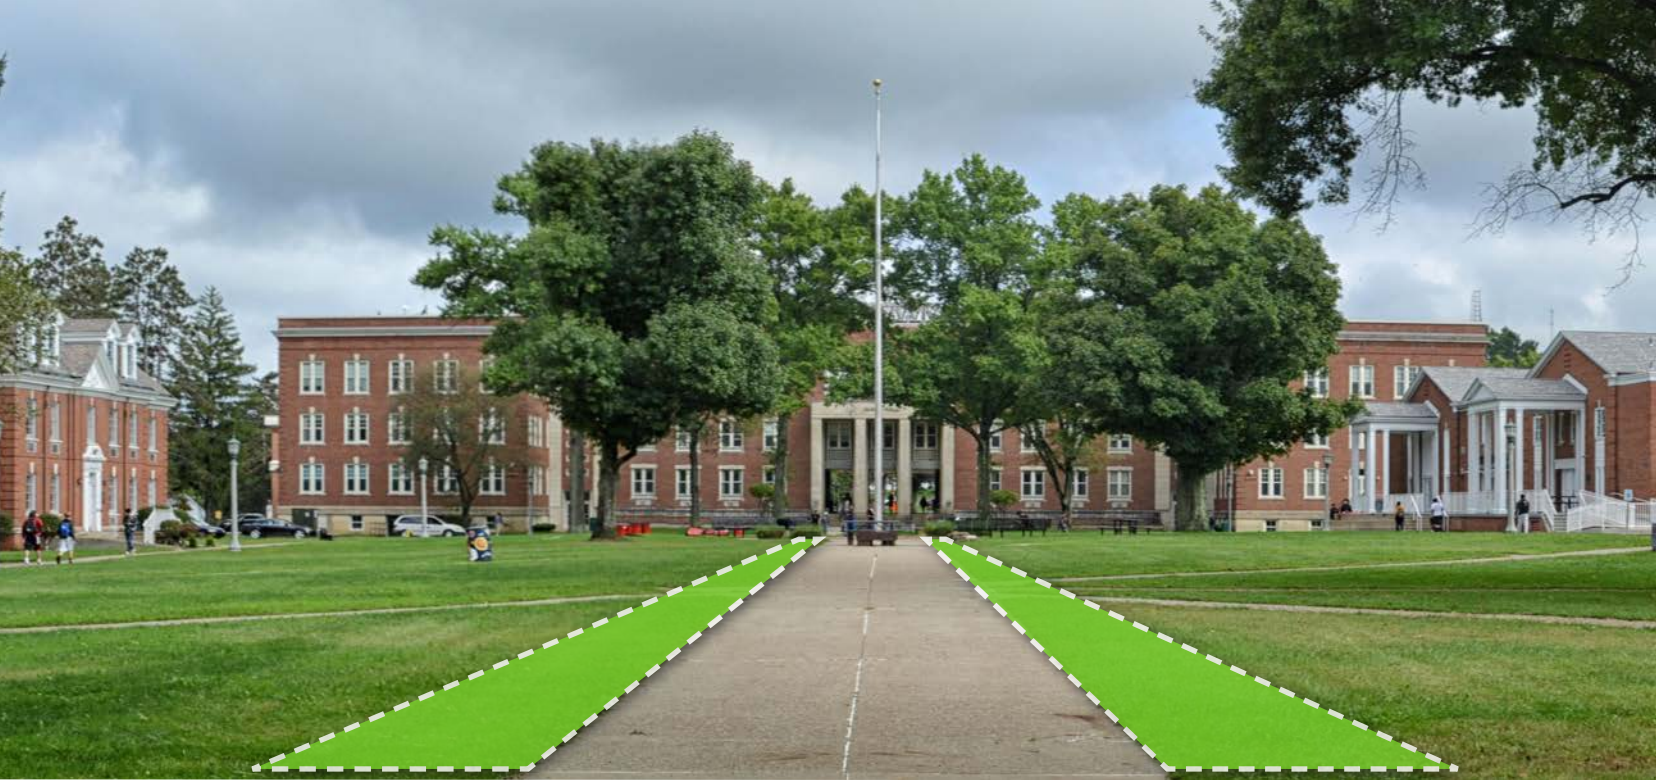
HOGE QUAD

For the most part, all the landscape shrubs and shade trees occur at the North and South ends of the plaza with a few patches of trees popping up between the framing buildings and near the center. Pedestrians tend to focus their passive time in these zones, enjoying the shade and seating that prevail there. Conversely, various recreational activities tend to take place in the more large open areas at the northern end where the turf is uninterrupted by the concrete walkways that are seen mostly criss-crossing along the southern half of the quad. Recommendations for landscape alterations in this area are largely dictated by the college's desires in how the space is used, but a few minor adjustments can help make a largely effective space become even more visually arresting and widely utilized.

1. REMOVE ANY EXTRANEOUS PATHWAYS ALONG SOUTHERN HALF TO CREATE MORE USABLE OPEN SPACE
2. STRENGTHEN THE VISUAL IMPACT OF THE MAIN AXIS PATHWAY WITH NEW FORMALIZED SHRUB LINES
3. CREATE SOFTER SCREENING OPTIONS FOR TRASH RECEPTACLES AND UNWANTED SIGHT-LINES
4. INTEGRATE NEW FOUNDATION EVERGREEN PLANTINGS & SHRUBS TO HELP SOFTEN THE WINTER APPEAL

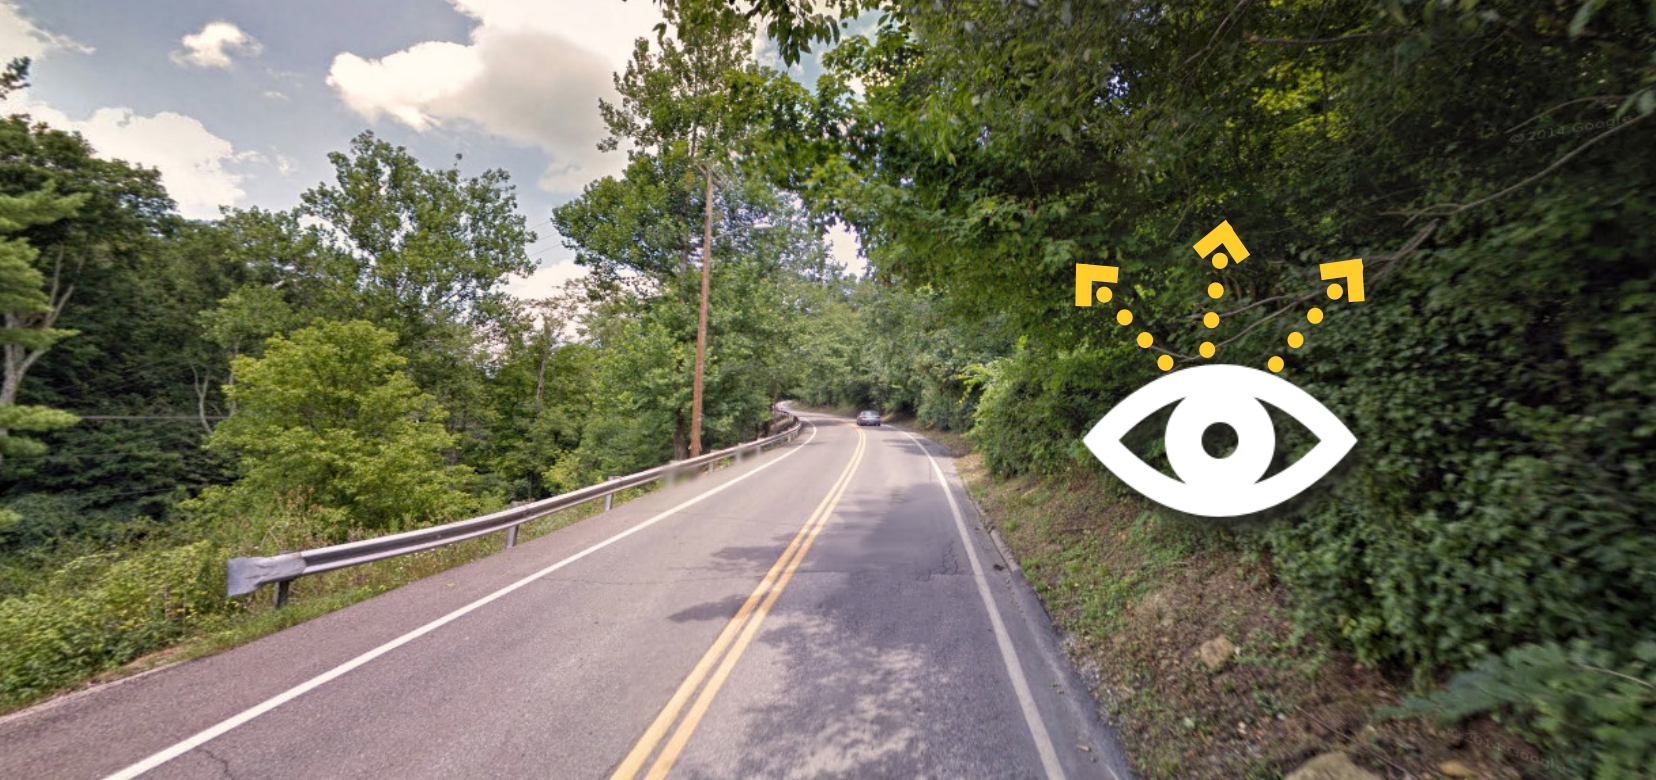
VAN METER WAY LANDSCAPE EDGE

The vehicular approach that comes up the hill from Van Meter Way's intersection with North Fork Road is heavily shrouded with natural landscape. The massing of plant life only breaks away a few feet before the lower entry into the site and can cause traffic to be unaware of exactly how close they are to arriving on campus. In conjunction with updated gateway elements that signal the campus approach (Section 02), creating visual corridors through the landscaped hillside and new aesthetic plantings can help increase the anticipation and understanding of exactly where the campus entries are. In addition, the mindful screening of the existing landscape can offer more opportunities for small pocket spaces that can be used for signage/banners or other college-related marketing pieces.

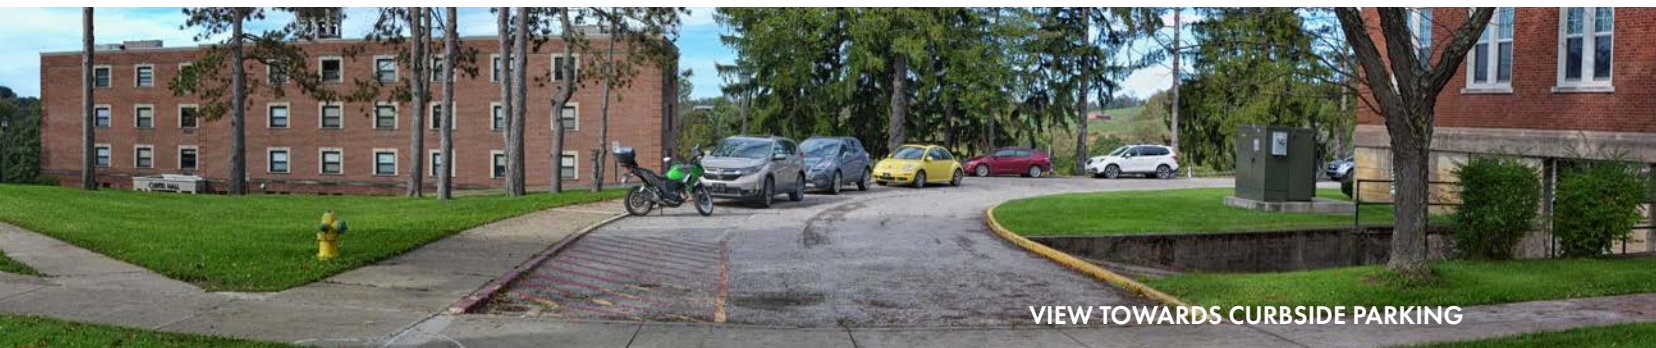
4. HOGE QUAD SPACE

As noted previously, the Hoge Quad is possibly the most notable and iconic space on campus and one that draws its identity from the form and placement of the open green space and the buildings that frame it. There is currently a visual gap in this formalized border near the southwest corner of Main Hall that is being used for curbside parking. By removing the parking and reformatting this area into a mixed-use outdoor classroom/recreation area with a new hardscape edge, seating, and landscape screening, the space can be improved upon and more widely utilized. This redesign would not only allow more programming options and encourage a healthier outdoor academia, but would also bolster safety by separating parking from the pedestrian core more effectively and screen unwanted sight lines. Additionally, the new hardscape edge would fill the last existing void space in the framing edge of the Quad and complete the symmetrical form that makes the area so visually appealing.

1. REMOVE CURBSIDE PARKING
2. REDESIGN AREA TO FUNCTION AS A MIXED-USE OUTDOOR CLASSROOM SPACE
3. INTEGRATE NEW HARDSCAPE EDGE TO COMPLETE QUAD FRAME AND BOLSTER SAFETY
4. INCORPORATE LANDSCAPE SCREENING

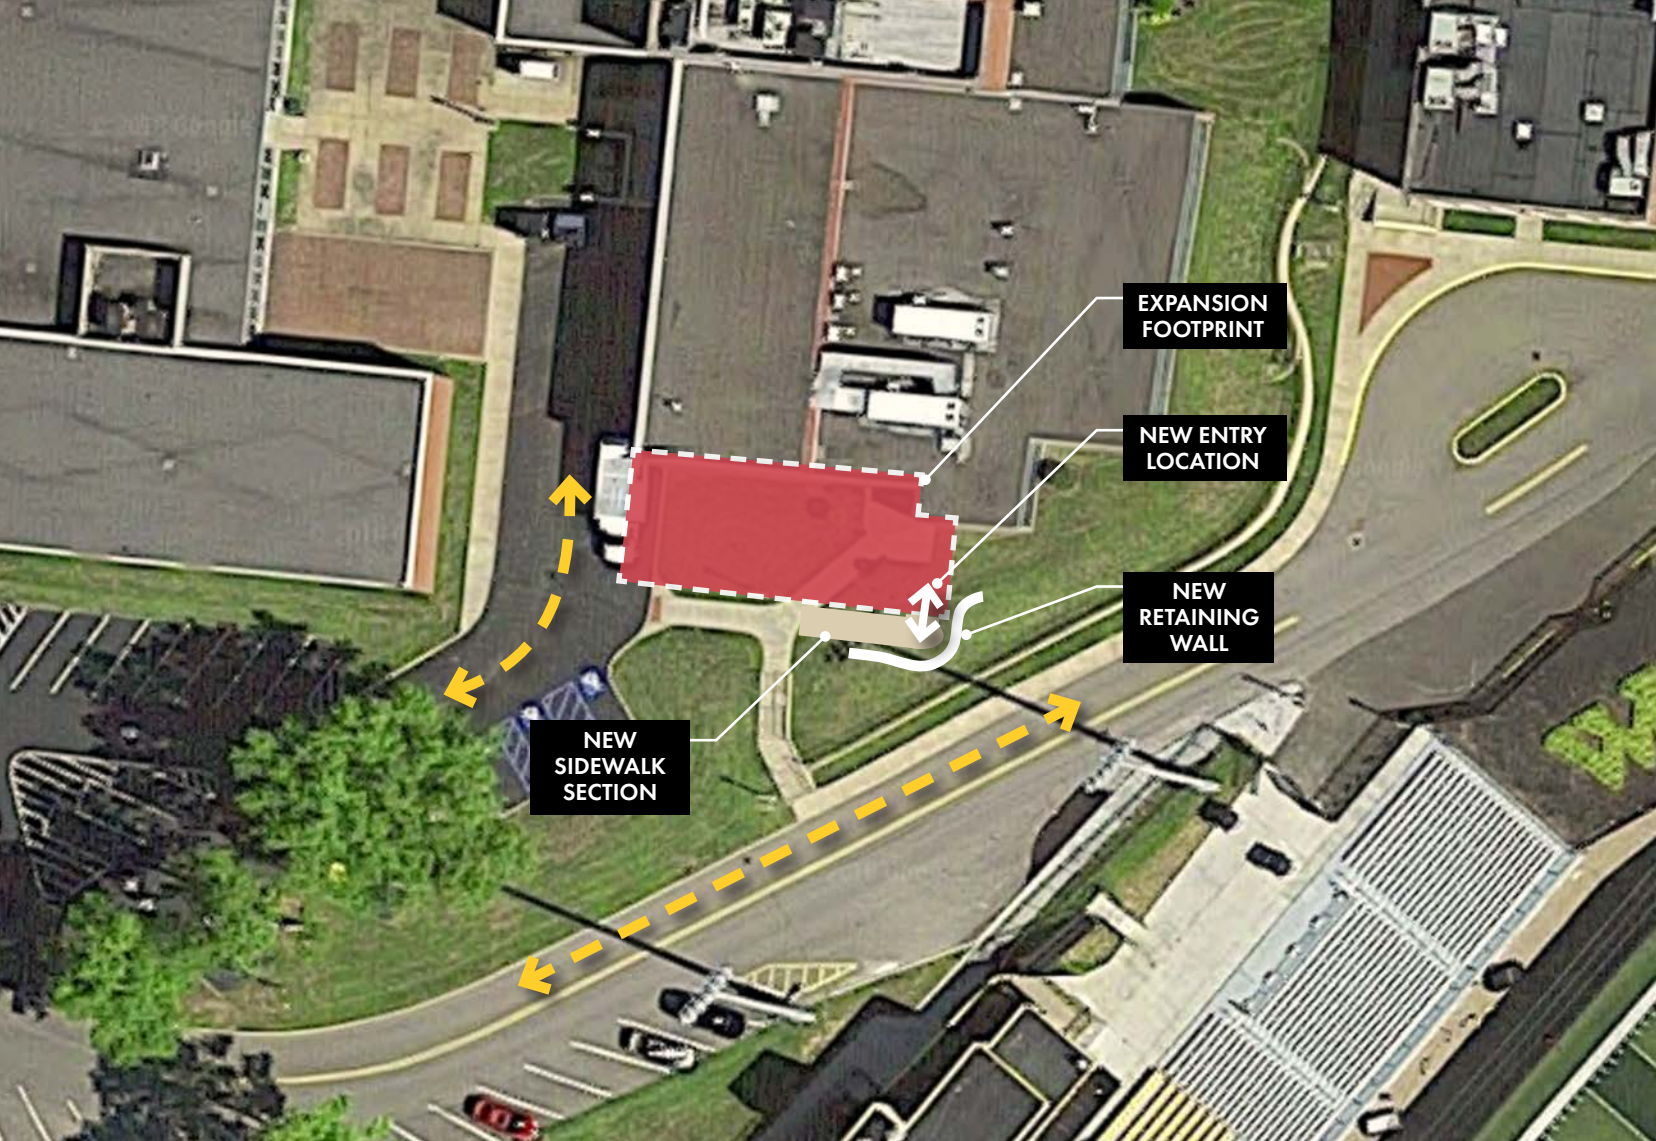
5. MEDIA ARTS CENTER EXPANSION

There is currently a completed design package for the expansion of the Media Arts Center that is set to be built in the near future. The goal of the design is to provide more classrooms and general space to the building in response to the growth in this sector of the college. Within the new design a TV News Studio and a News Room have been added along with updated connecting corridors. The existing sidewalks to the south of the building are being partially removed to allow access directly to the staircase that leads to South Drive. In addition, a revised retention wall section is being introduced to handle the larger building footprint.

1. CREATE MORE CLASSROOM SPACE FOR THE MEDIA ARTS AT SOUTH EDGE OF CURRENT BUILDING
2. ADJUST SIDEWALK CONNECTIONS AND ENTRYWAY
3. CREATE NEW RETAINING WALL

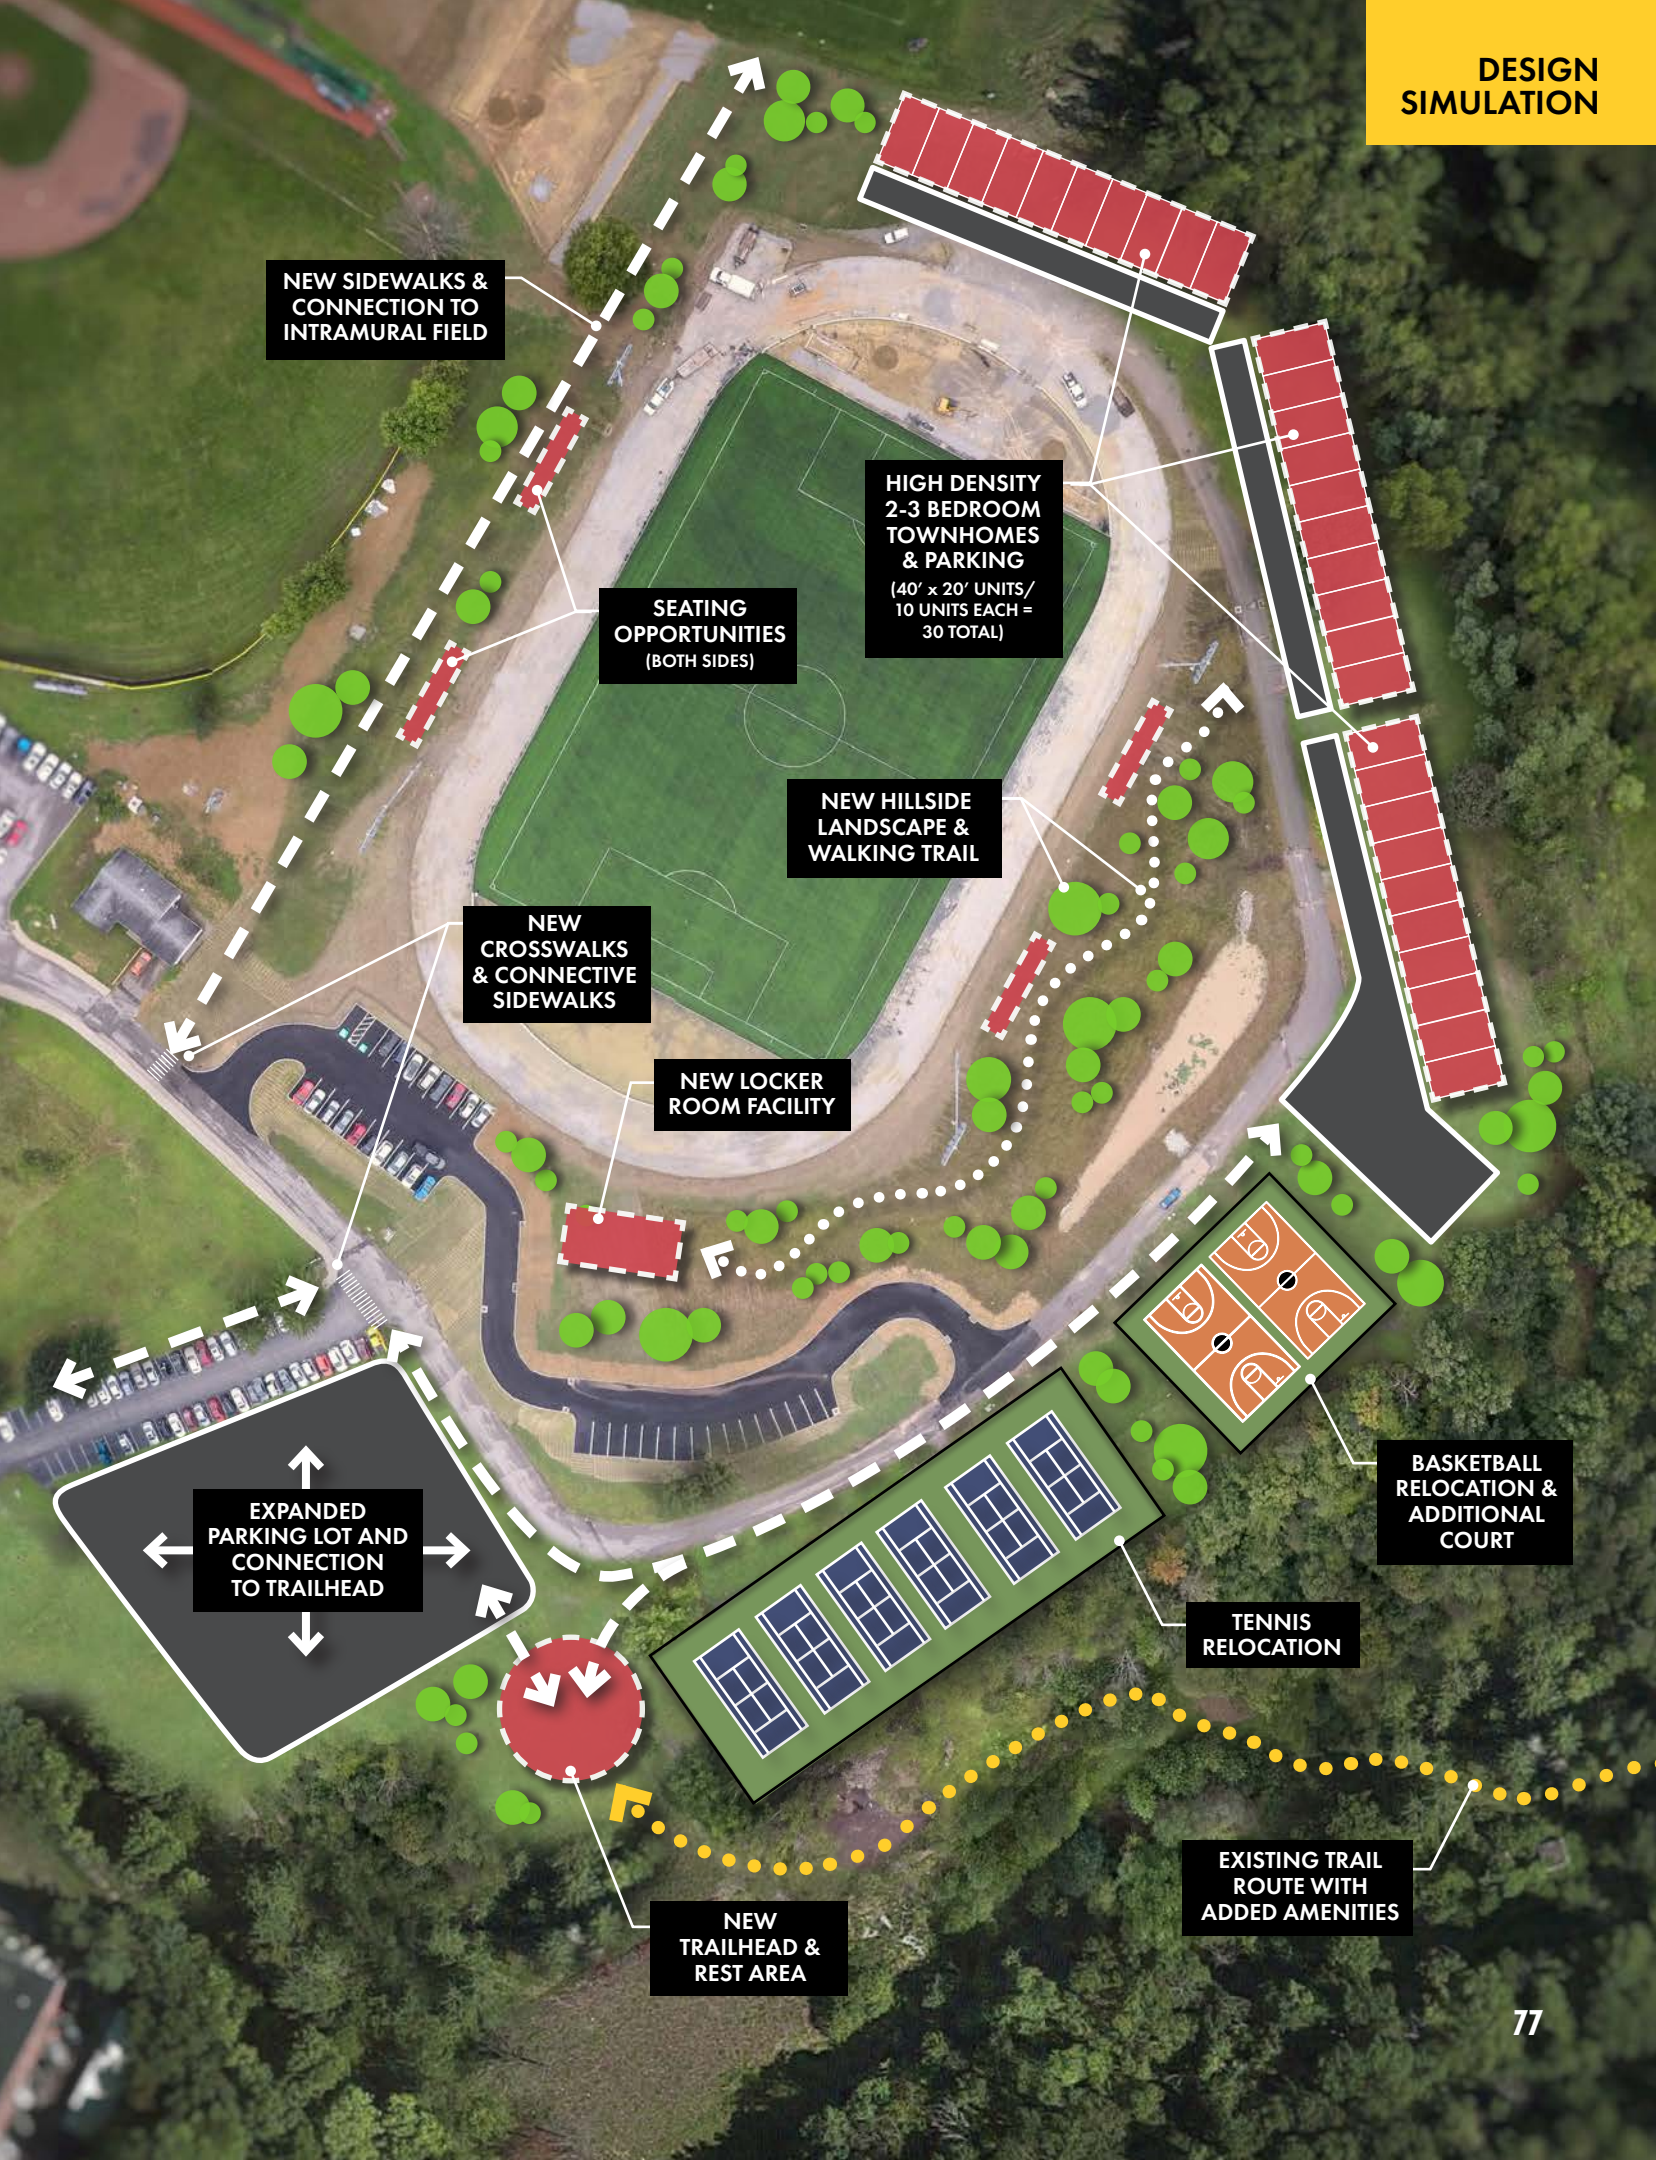
RECOMMENDATIONS

1. NEW SIDEWALK CONNECTIONS & CROSSWALKS
2. BASKETBALL AND TENNIS MIGRATION & IMPROVEMENTS
3. PLANNING FOR EXPANDED PARKING & TRAILHEAD AREAS
4. HOUSING REDESIGN

NEW SIDEWALKS &
CONNECTION TO
INTRAMURAL FIELD

SEATING
OPPORTUNITIES
(BOTH SIDES)

NEW
TRAILHEAD &
REST AREA

EXISTING TRAIL
ROUTE WITH
ADDED AMENITIES

Along the campus's easternmost edge exists the soccer field, tennis courts, and the residence area, The Commons. Design alterations are recommended here to help offer more parking, create a more inviting recreation area, trailhead, and improve the housing opportunities.

As noted in Section 04, there are many connective elements to this section of campus that are not addressed currently. Bringing people from the sidewalk near Campbell Hall as well as the leg that terminates near Meyers Maintenance Building are two of the major routes that could be expanded upon to create more seamless and safe transitions from the core areas of campus. By linking the existing sidewalks and weaving new ones through this area, it encourages pedestrians to not only explore further but to feel safe and comfortable in the more remote areas of campus.

With respect to Section 05, another recommendation may be to migrate the tennis courts to the east. The goal would be to build courts that require less constant maintenance while allowing for expanded parking in the location of the existing tennis courts. This entire line of planning is tied in with the development recommendations associated with the bioswale and drainage/retention of Campbell Hall and the wooded hillside as noted in the next item.

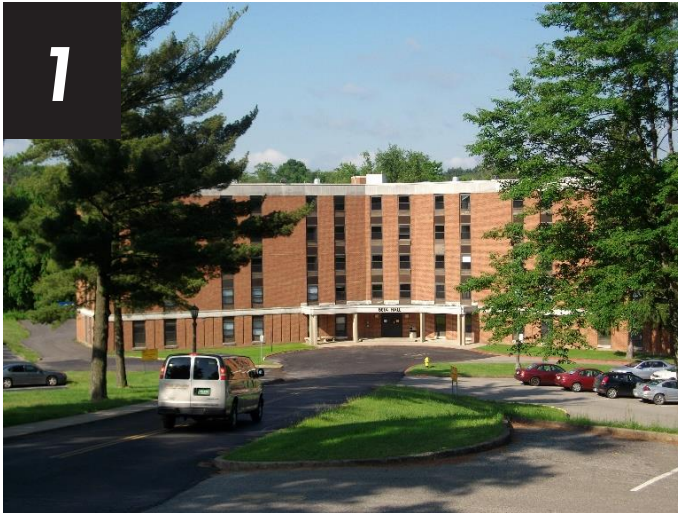
475 Beta Drive – Beta Hall houses 255 students in a co-ed, suite-style setting, with two rooms per suite separated by a bathroom. Each floor houses both male and female residents, dividing genders by suite. An ADA-accessible room is available in Beta Hall. Each floor has its own lounge for all residents to use. The RA Office is located on the first floor, along with laundry facilities and an additional kitchen lounge. Since fall 2016, Beta Hall has also housed first year students. Within the proposed 2018-2022 time period, Beta Hall is scheduled for demolition to provide for new housing.

- Refer to 2017 Cost Estimate (add 4% per year)
- Add cost to replace plumbing - \$500,000
- Includes plumbing impact on finishes

Requirement	Cost	Fiscal Year	Note
Replace plumbing			
Replace existing elevator	200,000		
	200,000		
Cost of Living Increase	16,320		
Revised Total with Cost of Living Increase	216,320		
Replace Plumbing	500,000		
Total	716,320
