West Liberty University

2019 CAMPUS MASTER PLAN
& RECOMMENDATIONS

WEST LIBERTY, WEST VIRGINIA

imi MILLS
GROUP

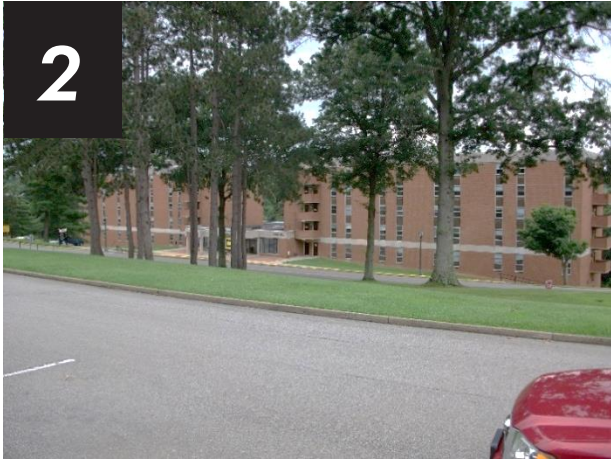
102 South Way – Krise Hall

102 South Way - Krise Hall, houses 304 students, both upper-classmen and first year students, in a co-ed, suite style setting, with two rooms per suite separated by a bathroom. Each floor houses either all male or all female residents. Honors housing and theme housing are provided for the first year area of this facility, with first preference for honors housing given to Elbin Scholars and Honors College students. Each floor has a lounge space, and each tower has a working kitchen. The main floor consists of a large lounge with free Wi-Fi, television, vending machines, ping pong table, and pool table, as well as laundry facilities and the RA Office.

- Refer to 2017 Cost Estimate (add 4% per year)
- Modified plumbing
 - 55,000 SF @\$15 = \$825,000
 - Includes plumbing impact on finishes
- Replace PTAC: general maintenance
- Ongoing Sprinkler and other maintenance
- Elevators (have been funded/removed from estimate)
- Add Fire Alarm work
- Add Roof \$100,000

Requirement	Cost	Fiscal Year	Note
Energy Efficient windows required	164,000		
Replace existing generator with higher capacity unit	25,000		
Replace plumbing throughout building			Unknown
New HVAC controls			For energy efficiency; Unknown
New HVAC for ground level (basement) areas	600,000		
Replace PTAC units in rooms			
Install fire suppression, sprinkler system	100,000		
Replace two (2) elevators	400,000		
	889,000		
Cost of Living Increase	72,542		
Revised Total with Cost of Living Increase	961,542		
Fire Alarm Improvements			Unknown
New Roof	100,000		
Total	1,061,542

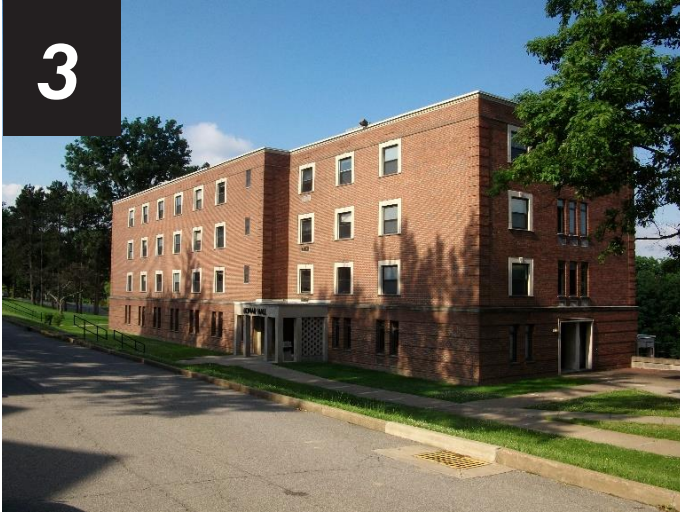
585 University Drive – Bonar Hall

585 University Drive, Bonar Hall is an upper-classmen building which houses 92 students in a co-ed, suite style setting. Bonar Hall is our honors facility and has a grade point average requirement with a minimum GPA of 3.5. Each floor houses both male and female residents, dividing genders by suite. The main floor consists of the RA Office, and lounge with free Wi-Fi and television. Each floor has a small kitchenette and small laundry room.

- Refer to 2017 Cost Estimate (add 4% per year)
- Chiller needs replaced

Requirement	Cost	Fiscal Year	Note
Replace existing windows	100,000		
New HVAC controls	13,000		For energy efficiency
Engineering Study			Heating for this building is furnished by a 2 pipe system located in Curtis Hall. Recommend engineering study to separate this locaiton for reconstruction of heating facility.
	113,000		
Cost of Living Increase	9,221		
Revised Total with Cost of Living Increase	122,221

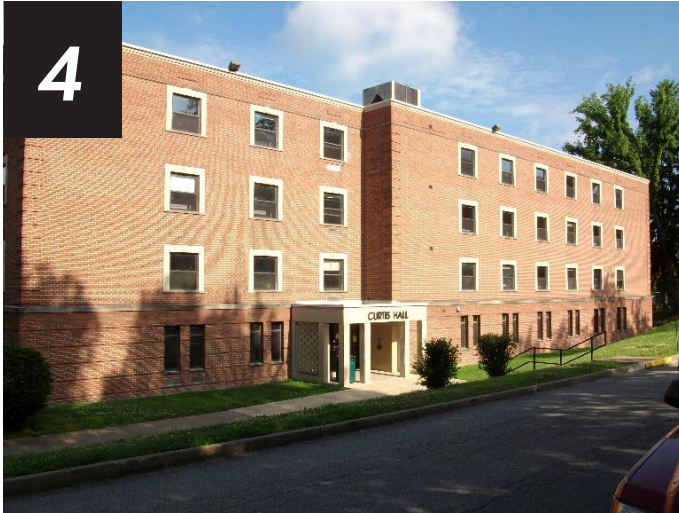
625 University Drive – Curtis Hall houses 124 first-year residents in a co-ed hall setting, with male residents on the first and second floors, and female residents on the third and fourth floors. Each floor has a community bathroom (with separate shower and restroom stalls), a small kitchenette and lounge. The first floor lounge also provides free Wi-Fi, a television, and vending machines. The RA Office and public restrooms are located on the first floor as well. Laundry facilities for the building can be found in the basement level of the building. Curtis Hall was named after General William B. Curtis and his family. Curtis was a general for Company D, the 12th West Virginia Regiment, during the Civil War.

Requirement	Cost	Fiscal Year	Note
Replace existing windows	100,000		
New HVAC controls	13,000		for energy efficiency
Engineering study			Heating for this building also furnishes service by a 2 pipe system to Bonar Hall. Recommend engineering study to separate this location for reconstruction of heating facility.
Replace existing generator	25,000		
	138,000		
Cost of Living Increase	11,261		
Revised Total with Cost of Living Increase	149,261

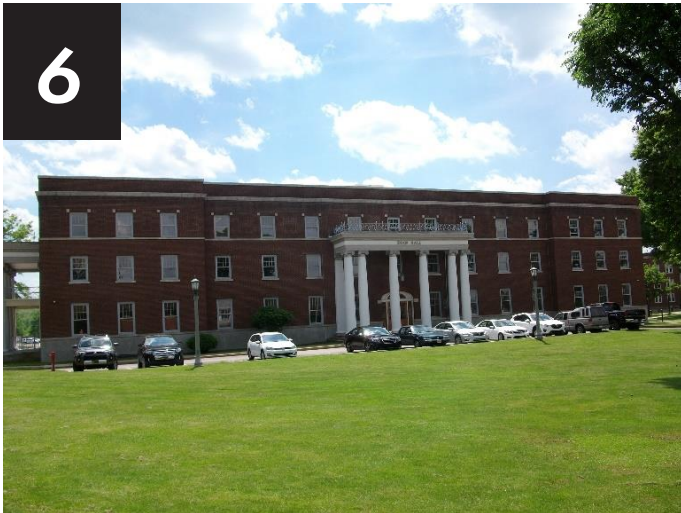
33 University Drive – Shaw Hall

Named after former President of WLU from 1908 to 1919, John Shaw, this structure is listed on the National Register of Historical Landmarks and houses major administrative offices including Campus Police, Health Services, Admissions, Enrollment Services, Visitor’s Center, Business Office, Human Resources, Institutional Advancement, President’s Office, Institutional Research, and the Provost’s Office.

- Recent renovations have the building in good condition
- Consider windows in the future

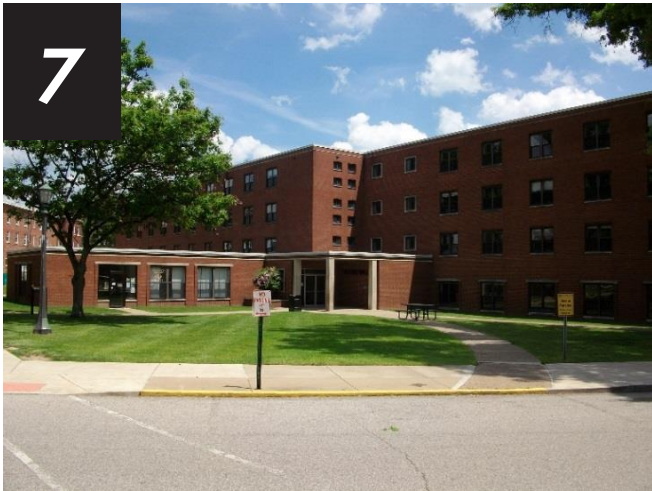
65 University Drive – Rogers Hall

Rogers Hall houses male and female residents in a traditional hall setting. Each floor of this building has two community bathrooms (with separate shower and restroom stalls), a small kitchenette and two small lounges. The RA Office and public restrooms are located on the first floor. Beginning in fall 2017, Rogers Hall will be offered as all private rooms at the regular room rate. Students will be able to enjoy a private room setting at no additional cost to the room charges.

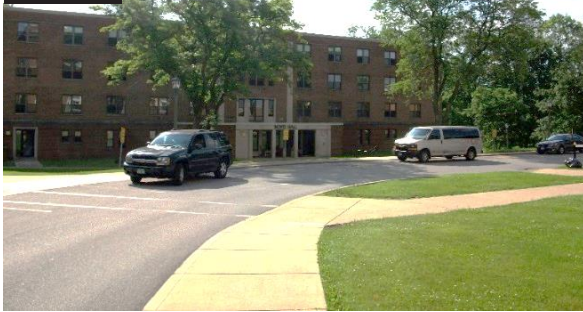
133 University Drive – Boyd Hall houses 134 male first-year residents in a traditional hall setting. Each floor of this building has a community bathroom (with separate shower and restroom stalls), a small kitchenette and a large lounge space. The first floor lounge also provides a television, vending machines and pool table. The RA Office and public restrooms are located on the first floor as well. Boyd Hall was named after Mrs. Robert Lee Boyd. Boyd served as a member of the West Virginia State Board of Education. She was from Wheeling.

- Refer to 2017 Cost Estimate (add 4% per year)
- Plumbing – Modify communal to ‘sauna bath’ individual units - \$400,000
- HVAC – Consider full replacement - \$700,000
- Fire Suppression
 - 35,500 @ \$3.00 = ± \$110,000

Requirement	Cost	Fiscal Year	Note
Replace existing generator with higher capacity unit	25,000		
Replace plumbing throughout building			Unknown
Replace HVAC system	13,000		
New HVAC controls			For energy efficiency; Unknown
Install fire suppression system	50,000		
	75,000		
Cost of Living Increase	6,120		
Revised Total with Cost of Living Increase	81,120		
Plumbing - Modify communal to 'sauna bath' individual units	400,000		
Full HVAC Replacement	700,000		
Fire Suppression	110,000		
Total	1,291,120

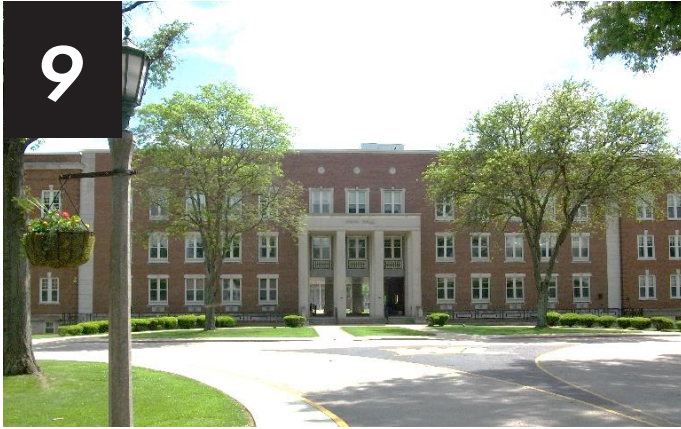
88 University Drive – Main Hall

This four-story structure, located on the circle just beyond the main entrance, houses several academic sections and also serves as the major classroom area. In addition, the administrative offices of information technology services are centralized here. The building includes the Curtis and McColloch wings, which were the two original academic facilities on campus. These structures were named for pioneer West Liberty families who played important roles in the early development of West Liberty.

Requirement	Cost	Fiscal Year	Note
Replace existing elevator	100,000		
New fan coil units needed in rooms (HVAC)	280,000		
			Suggest engineering study to determine if boiler at Main Hall is needed to provide heating for Library.
New boilers	2,024,738		
New HVAC controls	42,000		For energy efficiency
Replace fire alarm panel	50,000		
	2,496,738		
Cost of Living Increase	203,734		
Revised Total with Cost of Living Increase	2,700,472

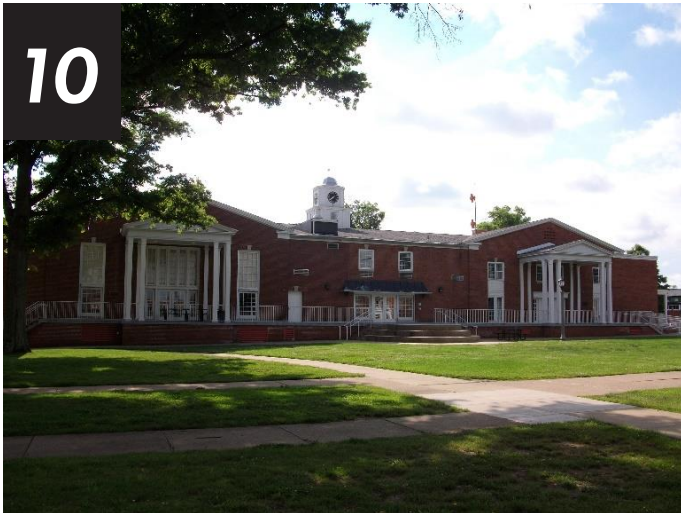
208 University Drive – Student Union is the center of activity for students, faculty and staff and is designed to enhance the quality of student life, support co-curricular activities and contribute to the University’s educational mission.

- Refer to 2017 Cost Estimate (add 4% per year)
- AC shared with Arnett (replacement underway)
- Heat: Consider boiler replacement
- Upgrade Fire alarm devices
- Space planning may impact other needs
- Plumbing needs work (kitchen is intensely used)

Requirement	Cost	Fiscal Year	Note
Install emergency generator	50,000		
Chillers			Cooling is provided by chillers located at Arnett Hall; suggest engineering study to determine if this is the most energy / cost efficient method
New HVAC controls	20,000		For energy efficiency
	70,000		
Cost of Living Increase	5,712		
Revised Total with Cost of Living Increase	75,712		
Upgrade Fire Alarm devices			Unknown

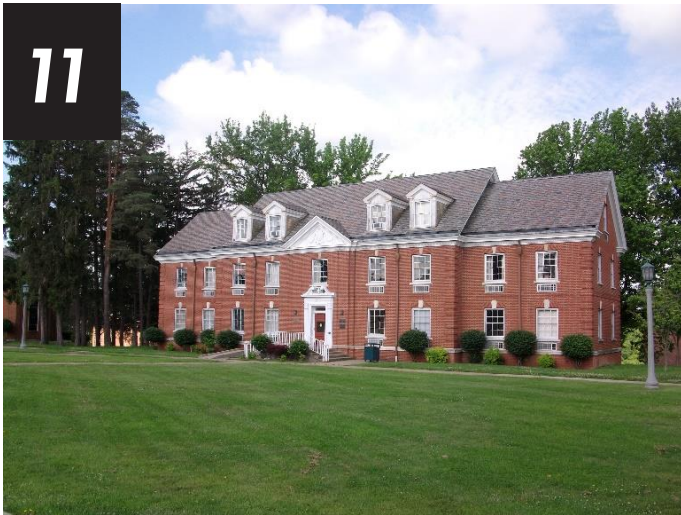
622 University Drive – Shotwell Hall

622 University Drive - Shotwell Hall is named after the founder of West Liberty Academy, Reverend Nathan Shotwell, D.D. and served as its leader until 1854. Dr. Shotwell is credited with the establishment of the high academic standards to which the University continues to aspire. Shotwell Hall is in need of major maintenance for ADA compliance, new roof and preservation. Shotwell Hall is listed in the National Register of Historic Places.

This is a recognized historically significant building with unique requirements concerning restoration and upgrades.

Requirement	Cost	Fiscal Year	Note
Upgrade HVAC	50,000		
Replace HVAC controls			For energy efficiency
Energy efficiency windows	46,000		
Replace slate roof and gutters	415,000		
Determine ADA requirements			
Replace electrical system	100,000		
Replace plumbing system			Unknown
Upgrade communications; WiFi	25,000	FY18 / FY19	Getting quote form DES
	636,000		
Cost of Living Increase	51,898		
Revised Total with Cost of Living Increase	687,898

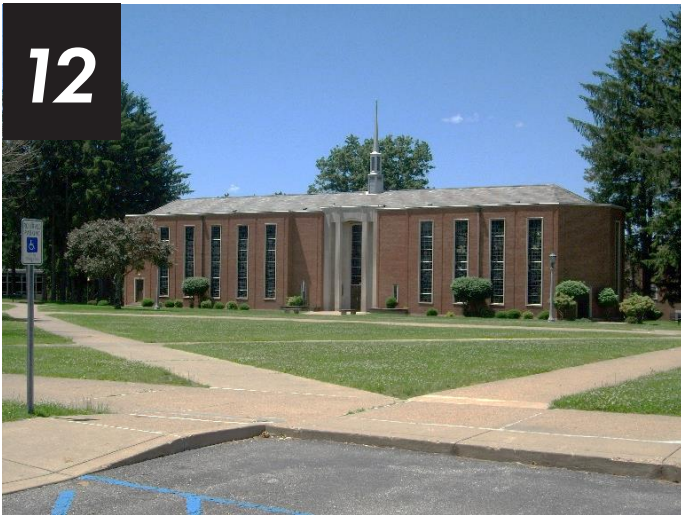
566 University Drive – Interfaith Chapel

Heating – Forced air electric heating and air conditioning

Requirement	Cost	Fiscal Year	Note
Upgrade HVAC	320,000		
Replace HVAC controls			for energy efficiency
Install insulating glass over stained glass windows	12,000		
	332,000		
Cost of Living Increase	27,091		
Revised Total with Cost of Living Increase	359,091

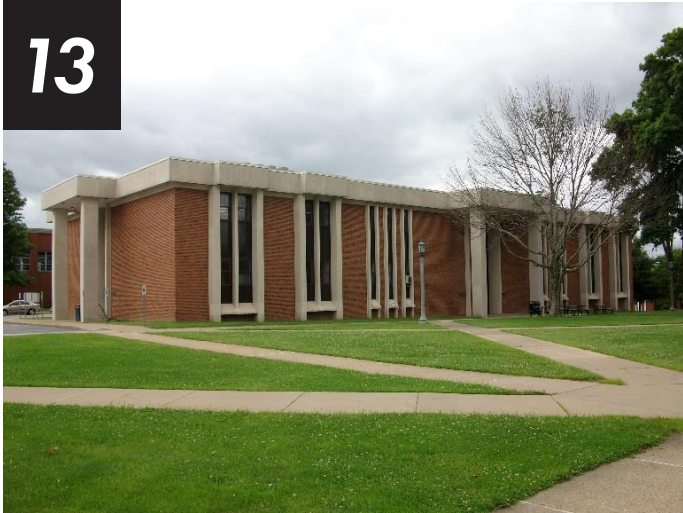
260 University Drive – Arnett Hall

Arnett Hall was named for Denver F. Arnett, Academic Dean of West Liberty from 1955 to 1970. The complex includes 12 laboratories, six general-purpose classrooms, faculty offices, and houses the biology and chemistry units. A modern greenhouse is located on the south end of the building. The excellent laboratories and equipment housed in this beautiful structure are to be found at very few undergraduate institutions in the nation.

Requirement	Cost	Fiscal Year	Note
Replace existing elevator	200,000		
Replace existing HVAC	800,000		Cooling is provided to Student Union by chillers located at Arnett; suggest engineering study to determine if this is the most energy / cost efficient method.
Replace existing generator transfer equipment	5,000	FY18	Suggest electrical capacity study to determine generator load. This is in progress.
Energy efficient windows required	54,000		
New HVAC controls	42,000		for energy efficiency
	259,000		
Cost of Living Increase	21,134		
Revised Total with Cost of Living Increase	280,134

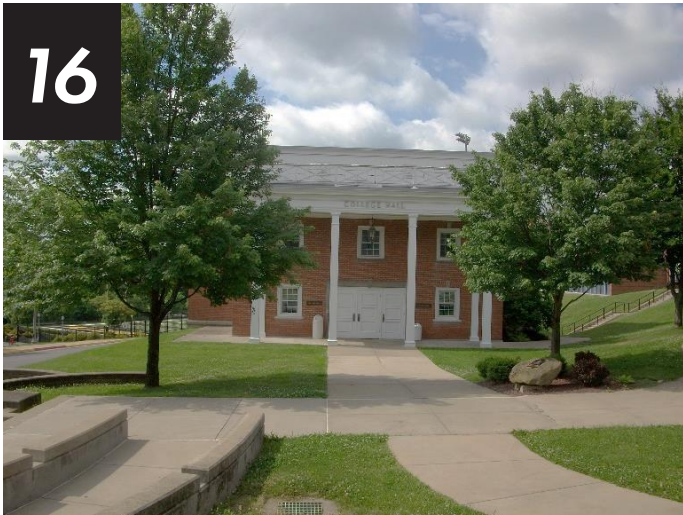
362 University Drive – College Hall is used primarily by the Music Program for classes, concerts, rehearsals, recitals, etc.

Requirement	Cost	Fiscal Year	Note
Exterior Painting	12,750		
Renovate offices / rooms on third floor	50,000		
Energy efficient windows	35,000		
New HVAC controls	20,000		for energy efficiency
	117,750		
Cost of Living Increase	9,608		
Revised Total with Cost of Living Increase	127,358

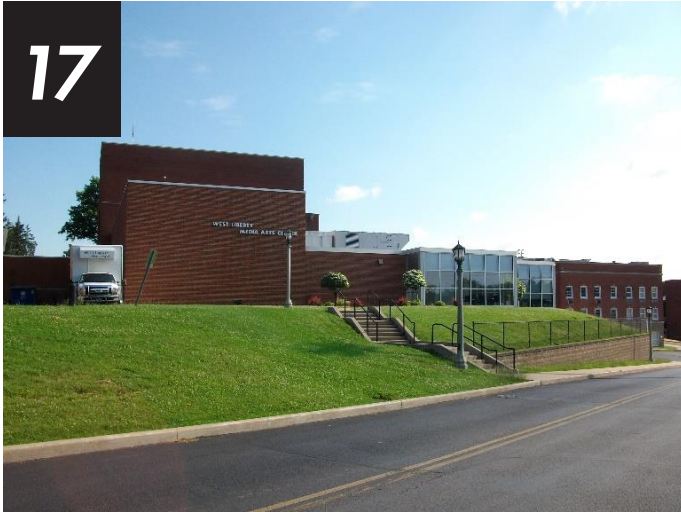
Building Area - 10,594 sq. ft.

- Building in good condition

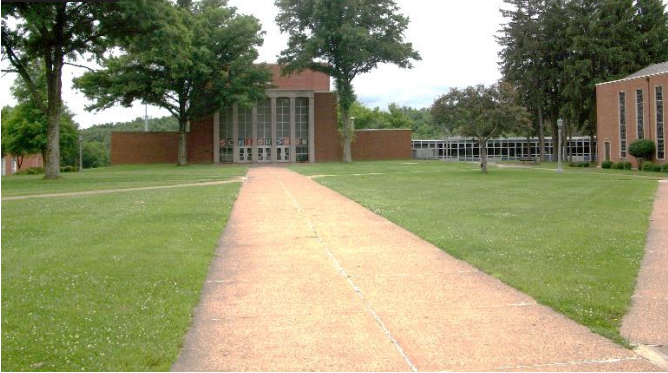
450 University Drive – Hall of Fine Arts

450 University Drive, Hall of Fine Arts - April of 1965 marked the groundbreaking for the construction of West Liberty’s Hall of Fine Arts Building. Although the building seems to be something students now have accepted as a normal part of the campus, the construction of the Hall of Fine Arts building was a major event in its time. The building includes Kelly Theatre, art studios, an art gallery, music practice rooms, piano labs, a choral room, band rooms, general classrooms and faculty offices. The addition of the Hall of Fine Arts not only added more courses and concentrations on campus, but it also produced many talented alumni while also making it possible for many great guest artists, performers, and important figures to appear at West Liberty.

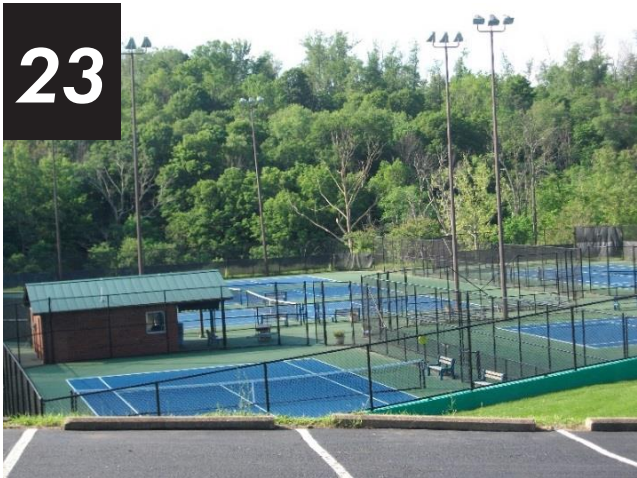
288 Faculty Drive Edgar Martin Tennis Courts

- Recommended for relocation
- Due to ongoing land slippage maintenance
- Site recommended for other development

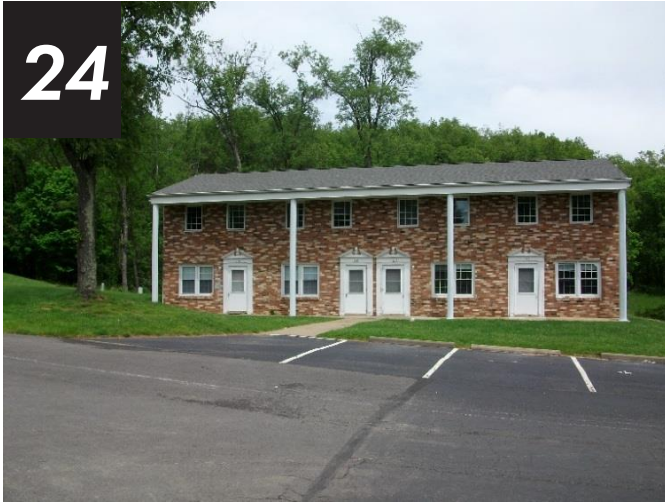
229-239 Residence Drive Commons Apartments

- Life Safety
 - Attic Smoke Barrier needs installed
 - Electric Heating is inefficient
 - Needs Air Conditioning
 - Not consistent with Campus Architecture
 - Moderate consideration for demolition

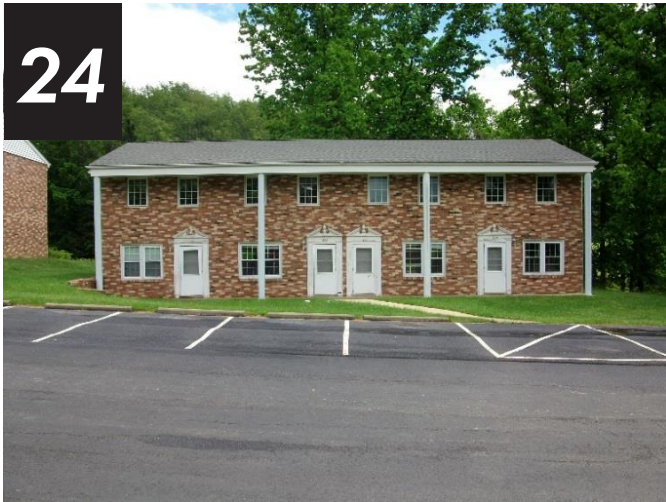
245-257 Residence Drive Commons Apartments

- Life Safety
- Attic Smoke Barrier needs installed
- Electric Heating is inefficient
- Needs Air Conditioning
- Not consistent with Campus Architecture
- Moderate consideration for demolition

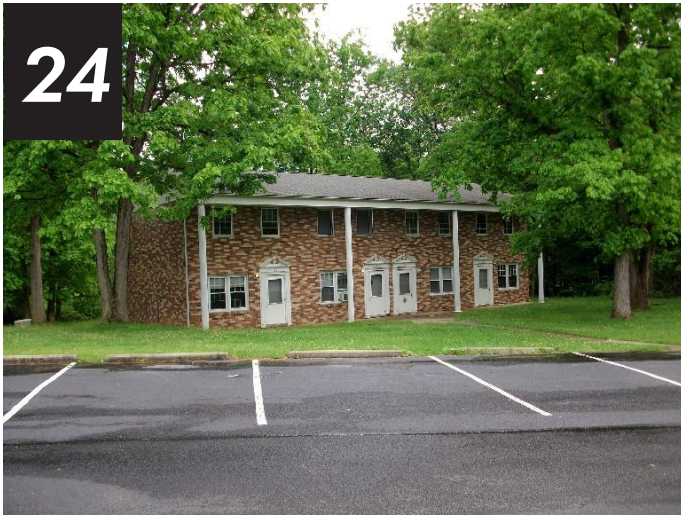
261-269 Residence Drive Commons Apartments

- Life Safety
 - Attic Smoke Barrier needs installed
 - Electric Heating is inefficient
 - Needs Air Conditioning
 - Not consistent with Campus Architecture
 - Moderate consideration for demolition

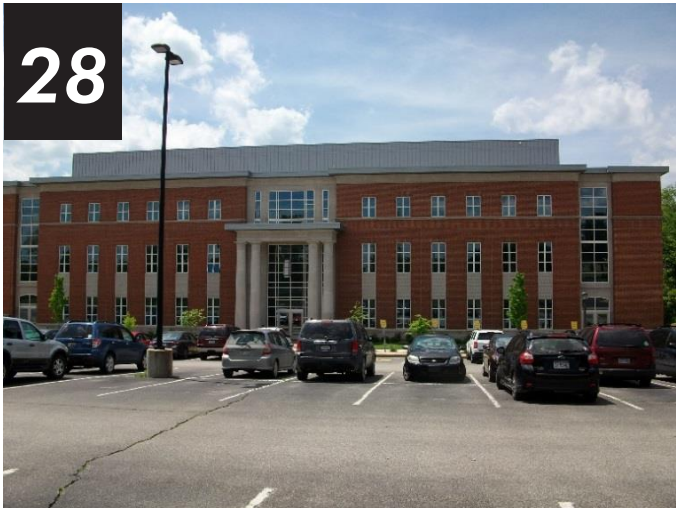
100 Faculty Drive – Campbell Hall

- Master Plan Deferred Maintenance Notes:**
- New Building in Good Condition
 - Fourth floor fit-out underway

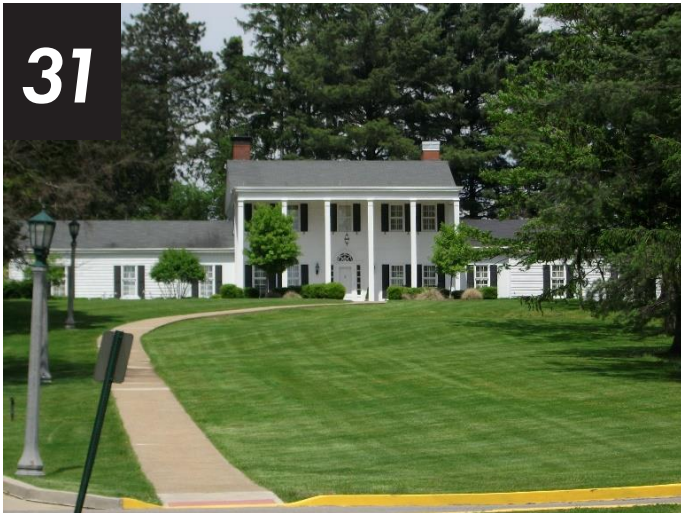
548 Van Meter Way – President’s House

- Refer to 2017 Cost Estimate (add 4% per year)
- Building in good condition

Requirement	Cost	Fiscal Year	Note
Install vinyl siding	32,000		
	32,000		
Cost of Living Increase	2,611		
Revised Total with Cost of Living Increase	34,611

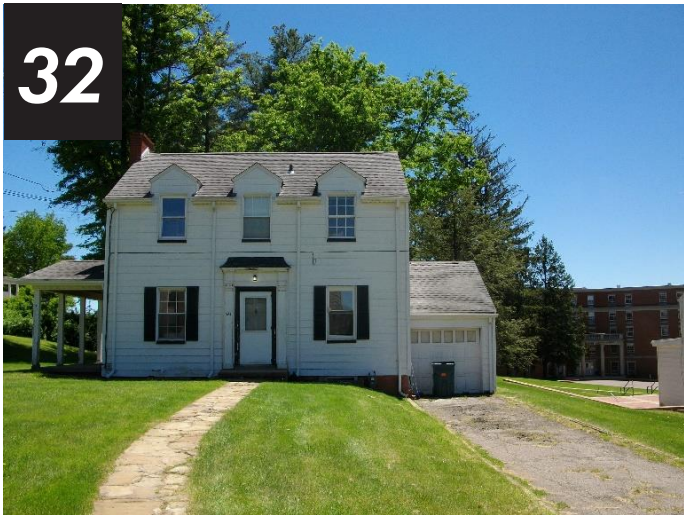
524 Van Meter Way – Student Housing

- New Siding
- Needs Air Conditioning
- Needs new Windows

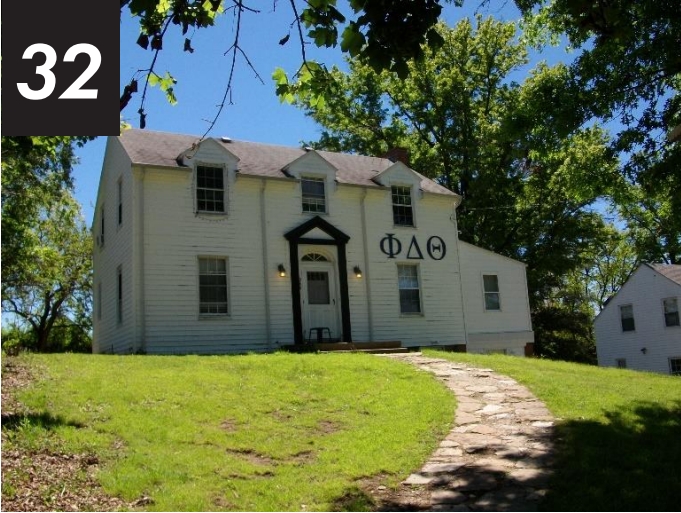
588 Van Meter Way – Student Housing

- Needs Air Conditioning
- Needs siding replaced
- Needs roof replacement
- Needs window replacement

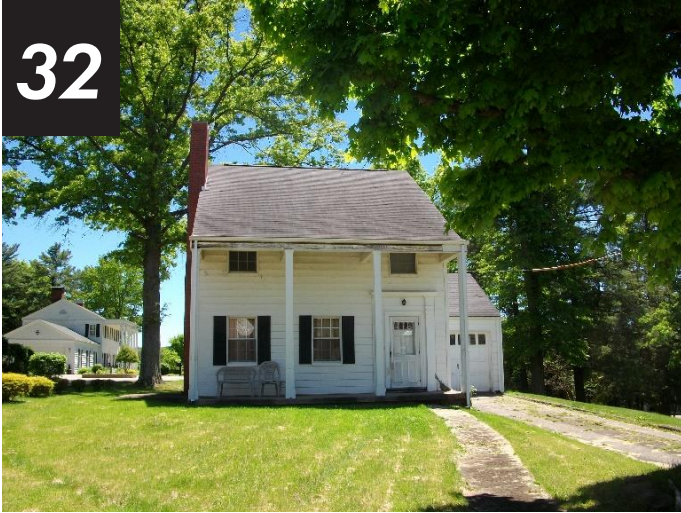
538 Van Meter Way – Student Housing

538 Van Meter Way was first occupied in 1935 and serves as the Theta Chi Fraternity House. This facility is normally used by upper level students.

- Needs Air Conditioning
- Needs window replacement
- Needs siding replaced

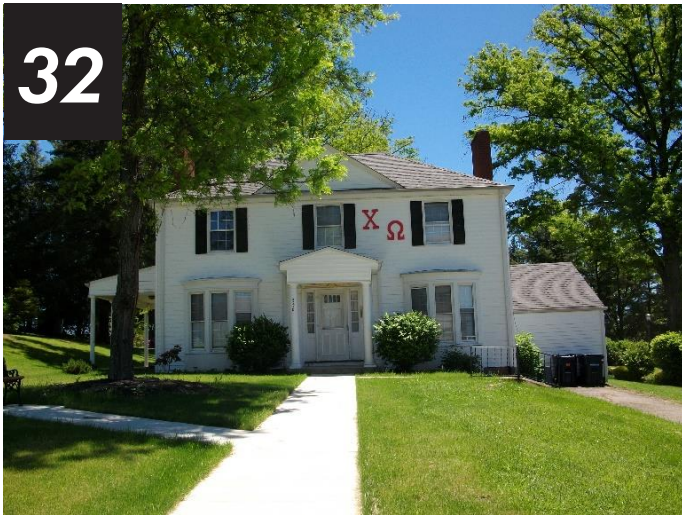
556 Van Meter Way – Student Housing

- Needs Air Conditioning
- Needs window replacement
- Needs siding replaced

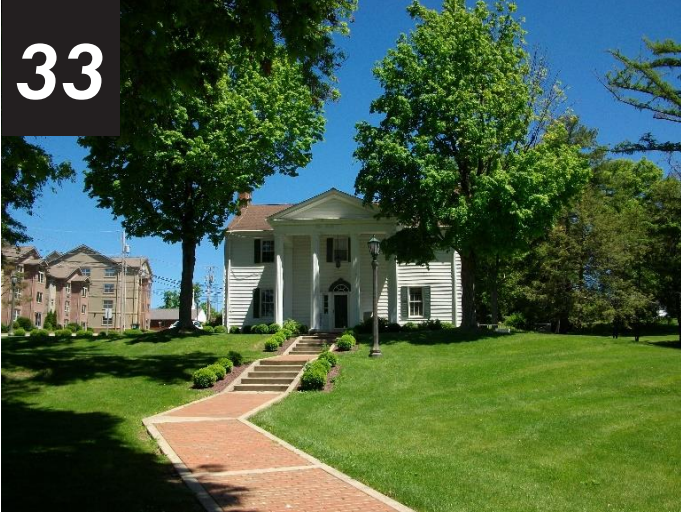
506 Van Meter Way – Liberty Oaks

506 Van Meter Way was first occupied in 1936 and proudly served as the residence for the President of West Liberty State College until 1997. Liberty Oaks Alumni House Bed & Breakfast now offers a charm and elegance that make it perfect for those seeking a quiet getaway. Liberty Oaks Alumni House Bed & Breakfast is a stately mansion located on the beautiful West Liberty campus. The property has many outstanding attributes such as its tranquil setting and proximity to all campus amenities including a state-of-the-art wellness center.

- Building in good condition

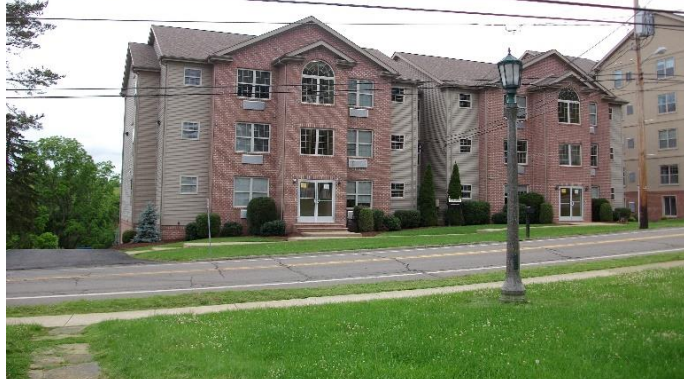
525 Van Meter Way – University Place I

525 Van Meter Way - University Place I consists of four apartments housing two residents in each apartment and twelve apartments housing three residents in each apartment. Each apartment has a shared living room, two bedrooms with their own individual bathroom, and a shared kitchen with stove/oven, refrigerator, and dishwasher. Apartments are furnished, and students are not permitted to bring large furniture items (i.e. couches, beds, etc.) Laundry facilities are available on the first level of the apartment complex, and parking is available behind the complex. One apartment on the first level is reserved for the residence life staff who oversees the apartments and houses.

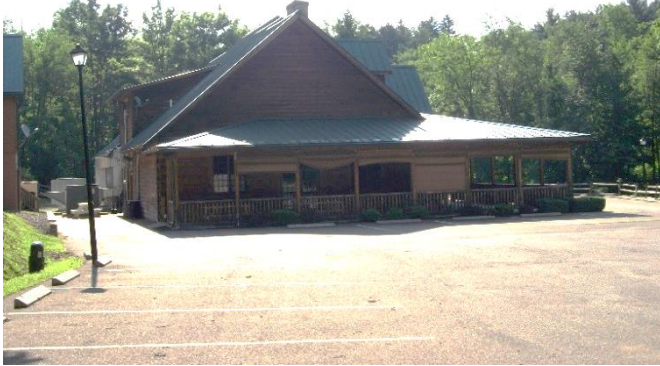
**260 Roadworthy Lane
Gary E West Event Center**

260 Roadworthy Lane was donated to West Liberty University in 2013 courtesy of alumnus and benefactor Gary E. West. This location provides the venue for hosting receptions, dinners and other similar activities capable of hosting a considerable number of people. A great number of these events were held in venues that lacked the proper capacity, convenient parking or the ability to provide the appropriate food service. In addition, there were occasions when more than one campus group wished to use a particular facility leaving other organizations without an adequate location to hold its event at the same time.

- General Maintenance
- Building in good condition

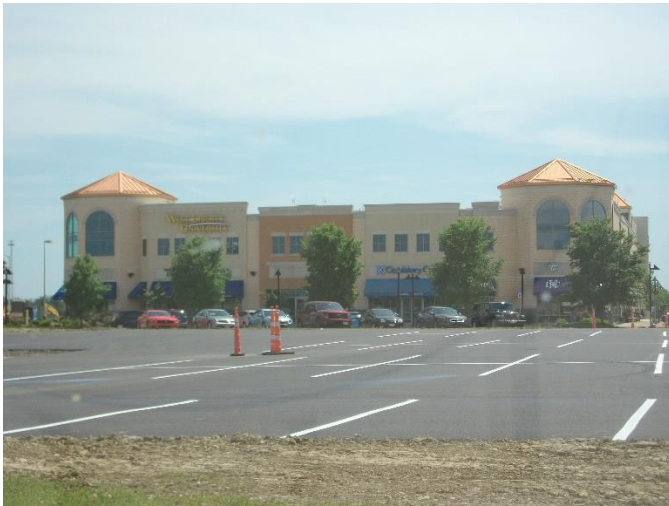
355 Wharton Circle - Highlands

355 Wharton Circle, The Highlands Center, provides a number of educational opportunities from undergraduate to graduate level courses and from continuing education to a full schedule of summer term courses. West Liberty University Highlands Center offers a variety of courses and is conveniently located right off Interstate 70 at the Cabela’s Drive exit. Programs at the Highlands Center include the Masters of Arts in Education, Regents Bachelor of Arts, Bachelor of Applied Science, and the Bachelor of Arts in Organizational Leadership and Administration. The Highlands Center also holds the majority of summer courses. The modern classrooms, Wi-Fi throughout the center, and accessibility make the Highlands Center an ideal location for learning.

- Building in good condition
